# Route Assessment of EuroVelo 6 Atlantic-Black Sea

in Germany, Austria, Slovakia, Hungary and Romania  
Final Report

Written by Aleksander Buczyński,  
Ernst Fahrenkrug and Ed Lancaster (ECF)  
November 2018

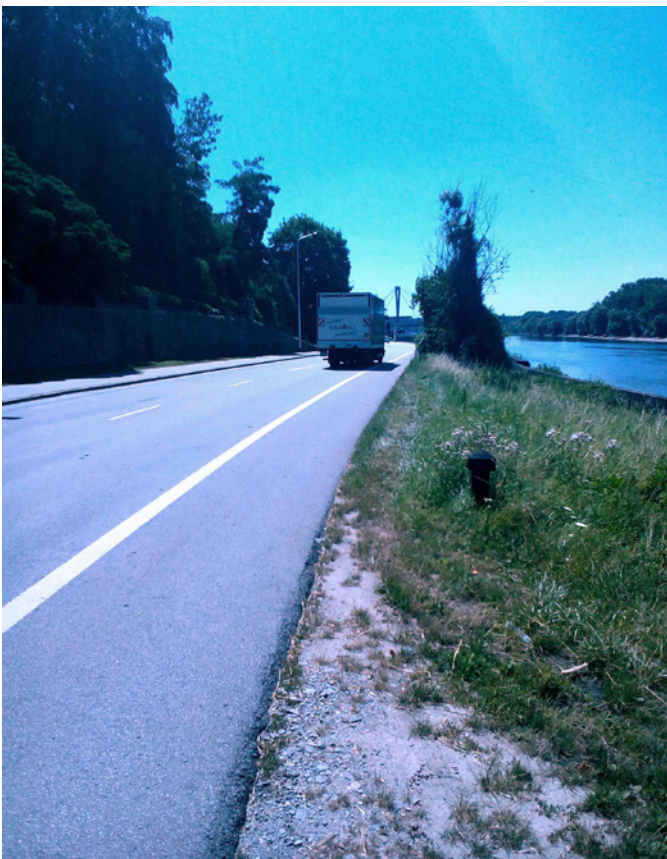
*Very high traffic on public road close to Deggenu (section 11). Painted cycle lane/paved shoulder with width of less than 1.5 m.*

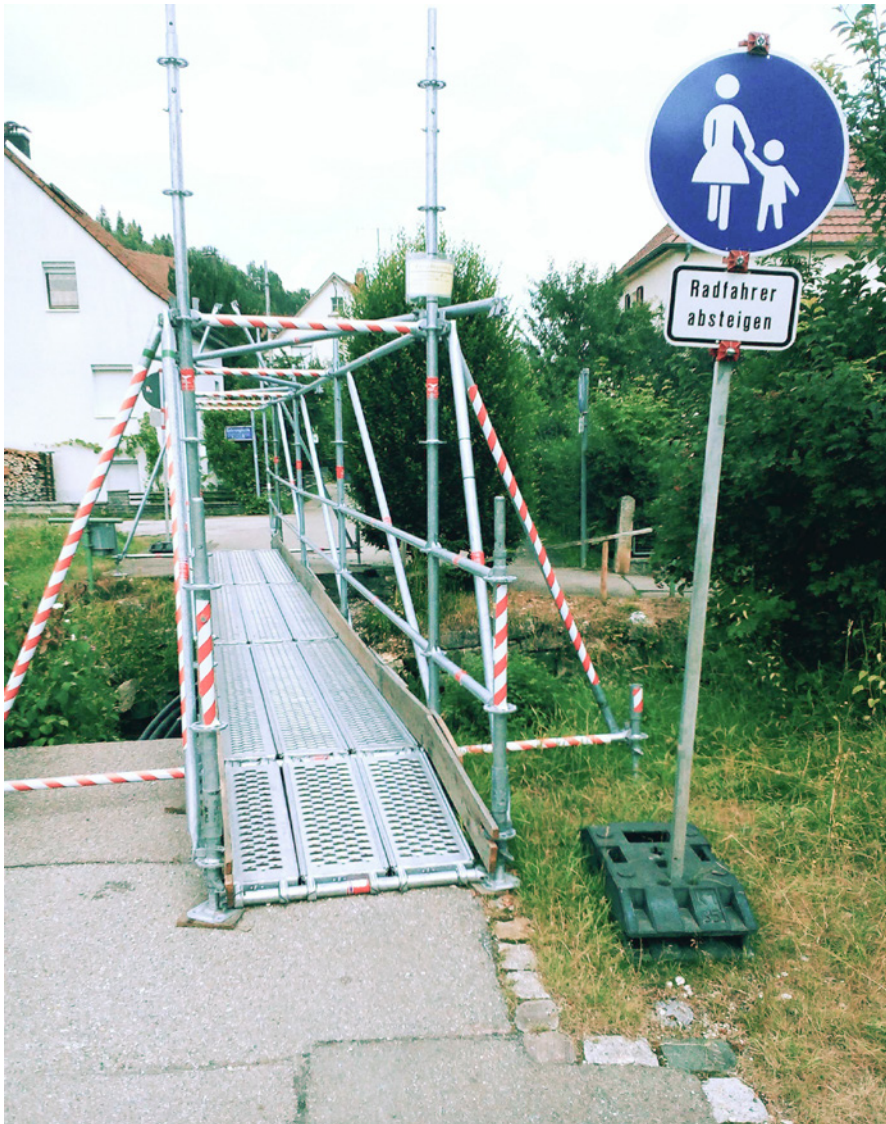
*In Tuttlingen (daily section 1), cyclists have to dismount.*

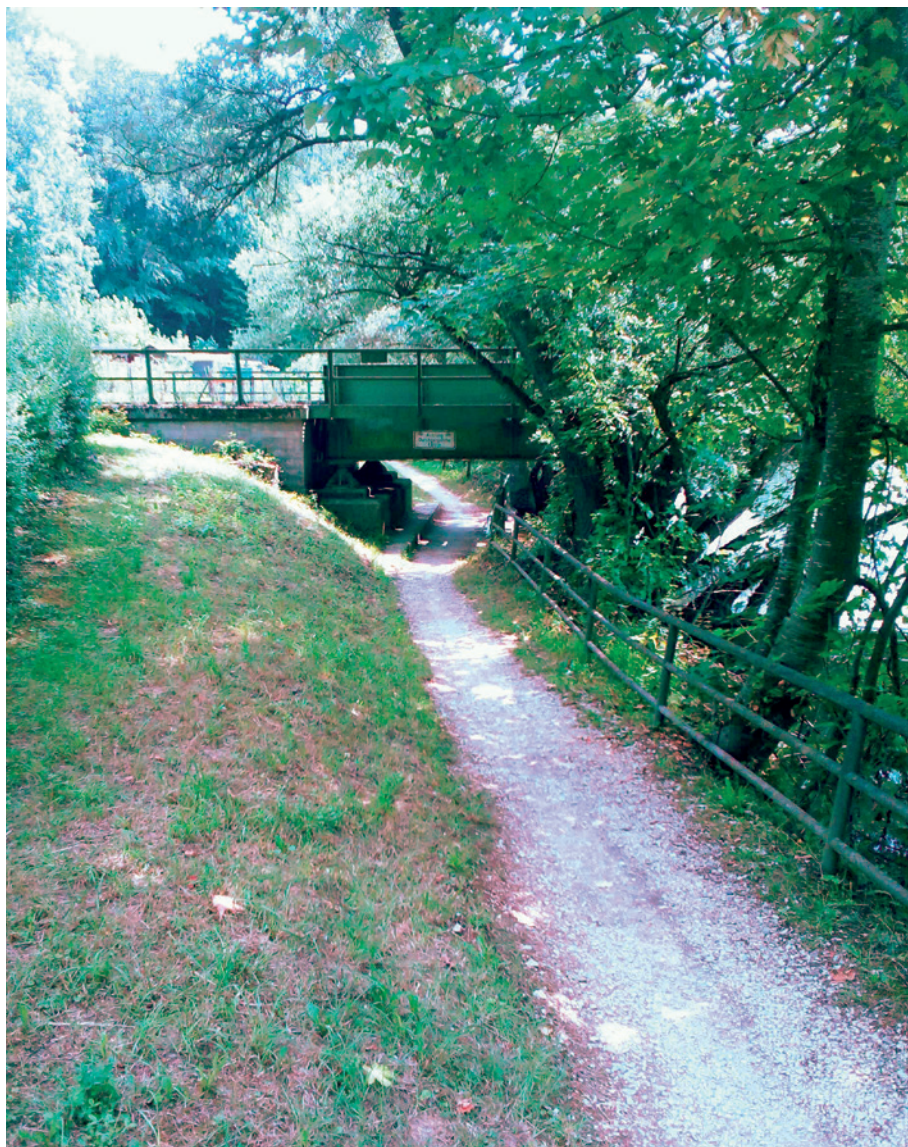
*Quite narrow cycle path at entry to Scheer (section 2).*

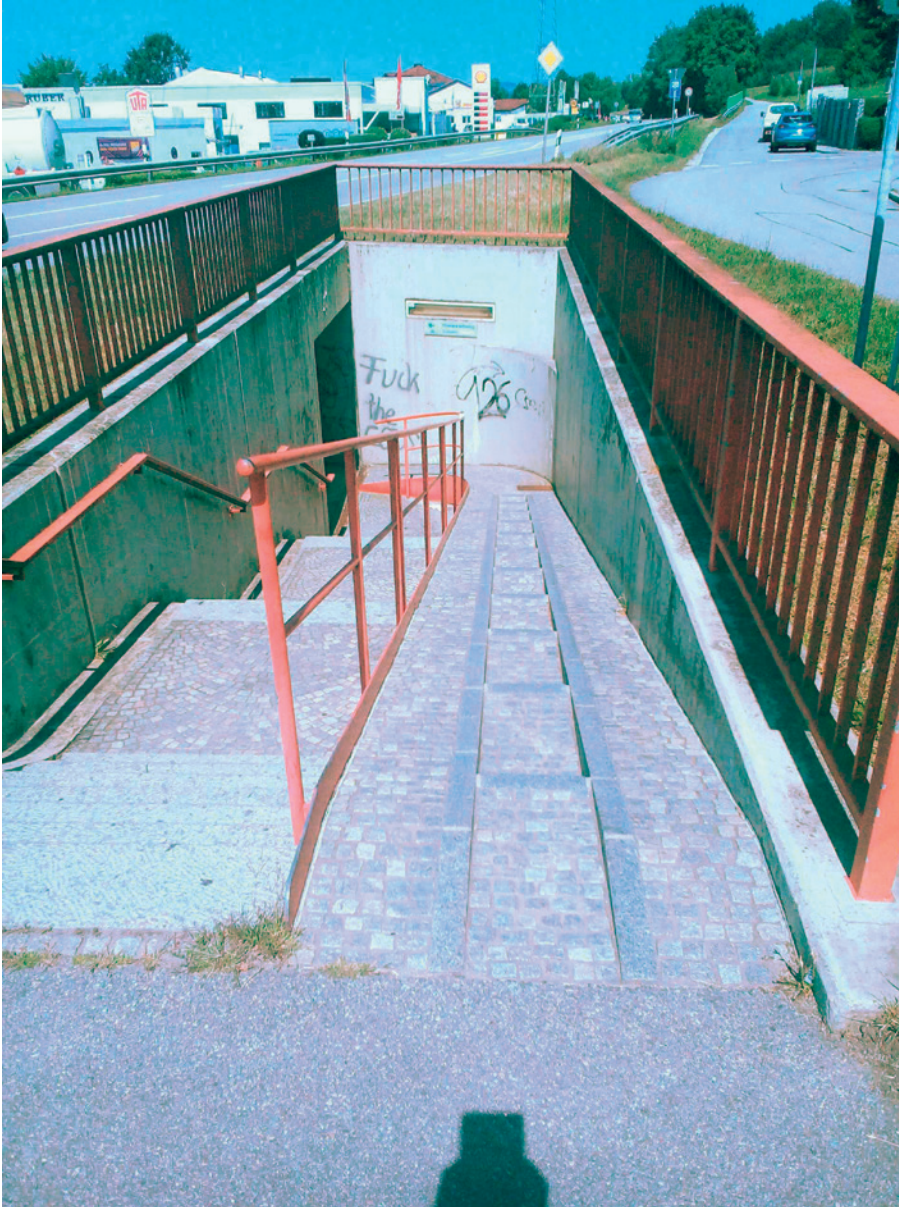
*Stairs with ramp but barely visible sign close to Passau (section 12). Dark underground passage could also be a social safety challenge.*

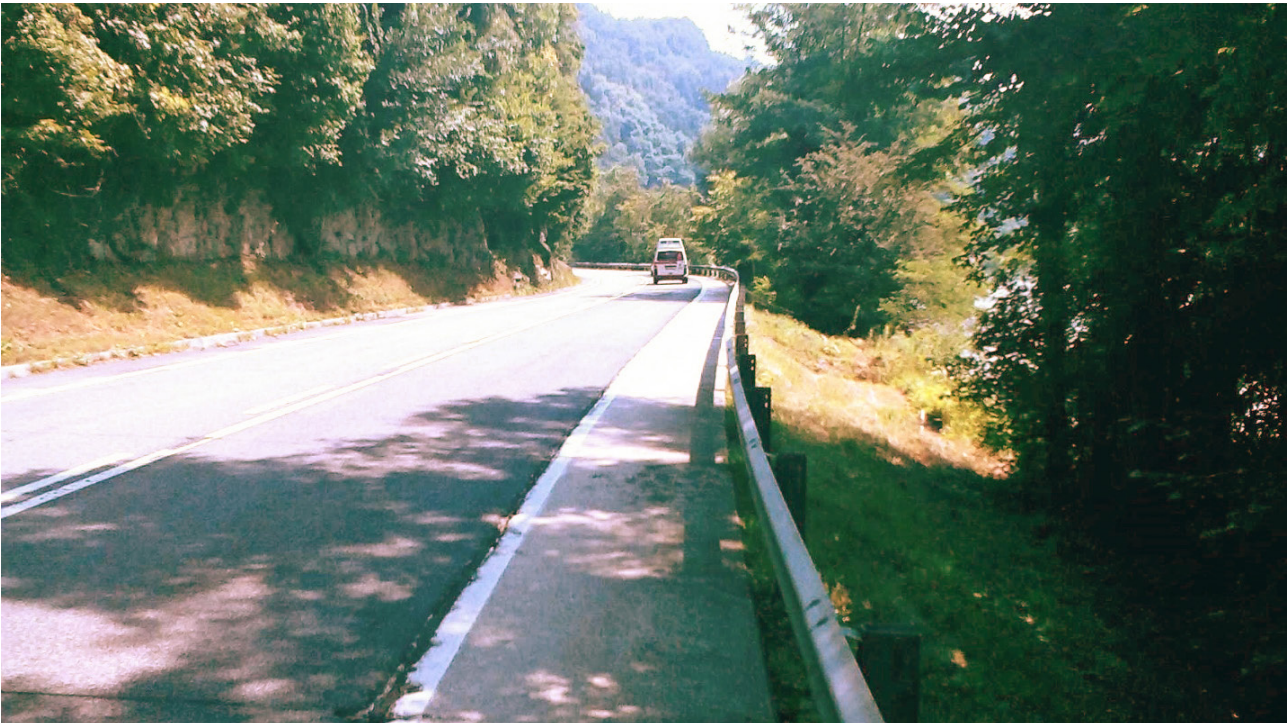
*Paved shoulder on road number 3 between Grein and Hirschenau (daily section 17) – too narrow for safe cycling outside built-up area, effective width further reduced by safety barrier.*

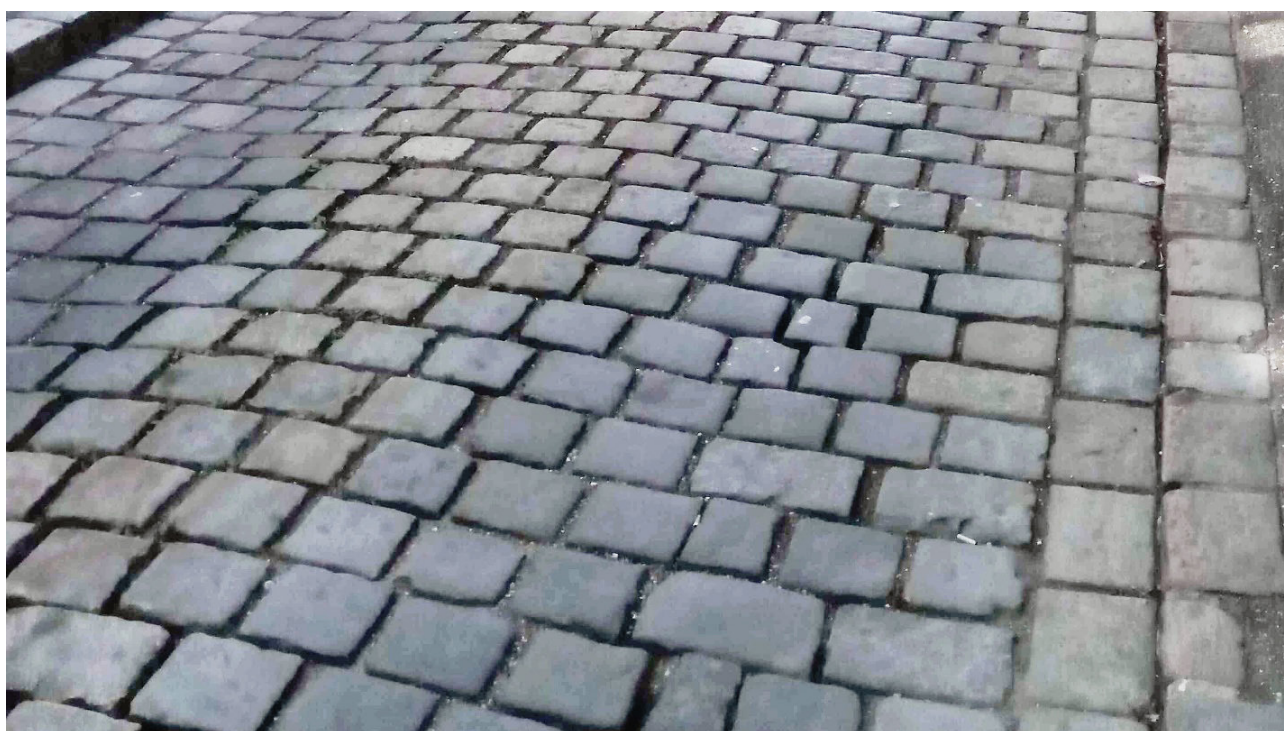
*Cobblestones with big gaps in between in the centre of Ybbs an der Donau (daily section 25).*

*Bike friendly cobblestone treatment in Freiburg im Breisgau – similar measures could be applied in Ybbs an der Donau.*

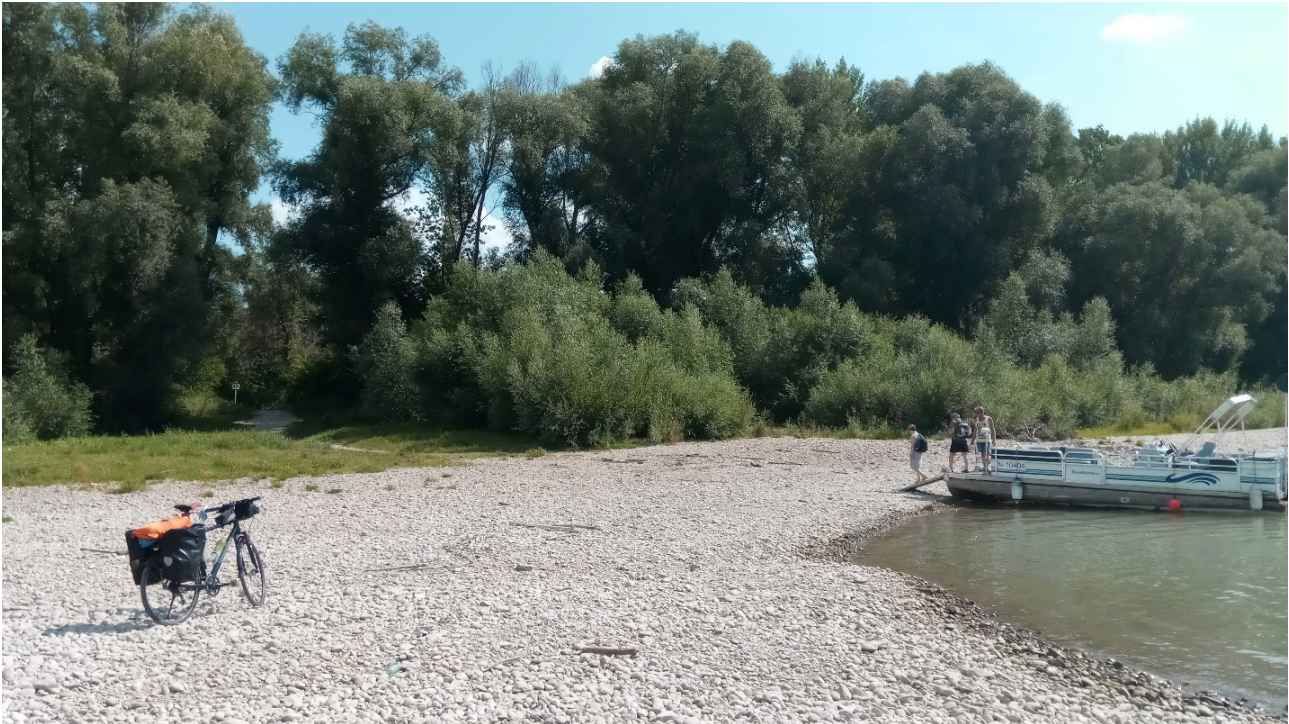
*Difficult access to ferry in Haslau an der Donau (pebbles, sand, cobblestones, up to 25% gradient after taking the ferry).*

7. Better access to the ferry in Haslau an der Donau; alternatively, the option of developing a cycle route on the southern side of the Danube also between Vienna and Haslau an der Donau (not surveyed) could be explored.
8. Adding missing signs on 78 junctions (most of them in daily sections 17, 19-20 and 28).
9. Integrating EuroVelo logo on signs where it is missing – mostly in daily sections 14-16, 22-23 and 29.
10. Integrate public-transport timetables and explanations on signing into the Austrian websites promoting EuroVelo 6.

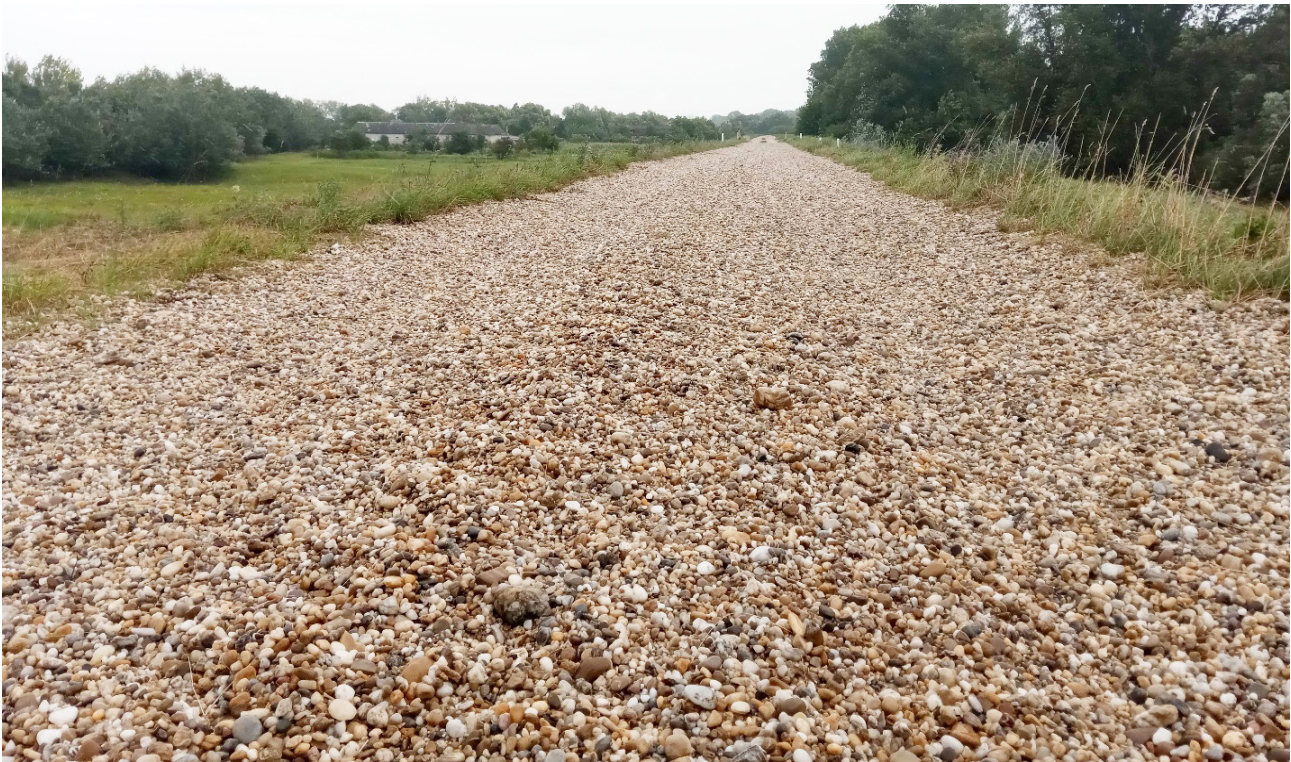
*Badly rideable, not consolidated gravel between Velké Kosihy and Nová Stráž.*

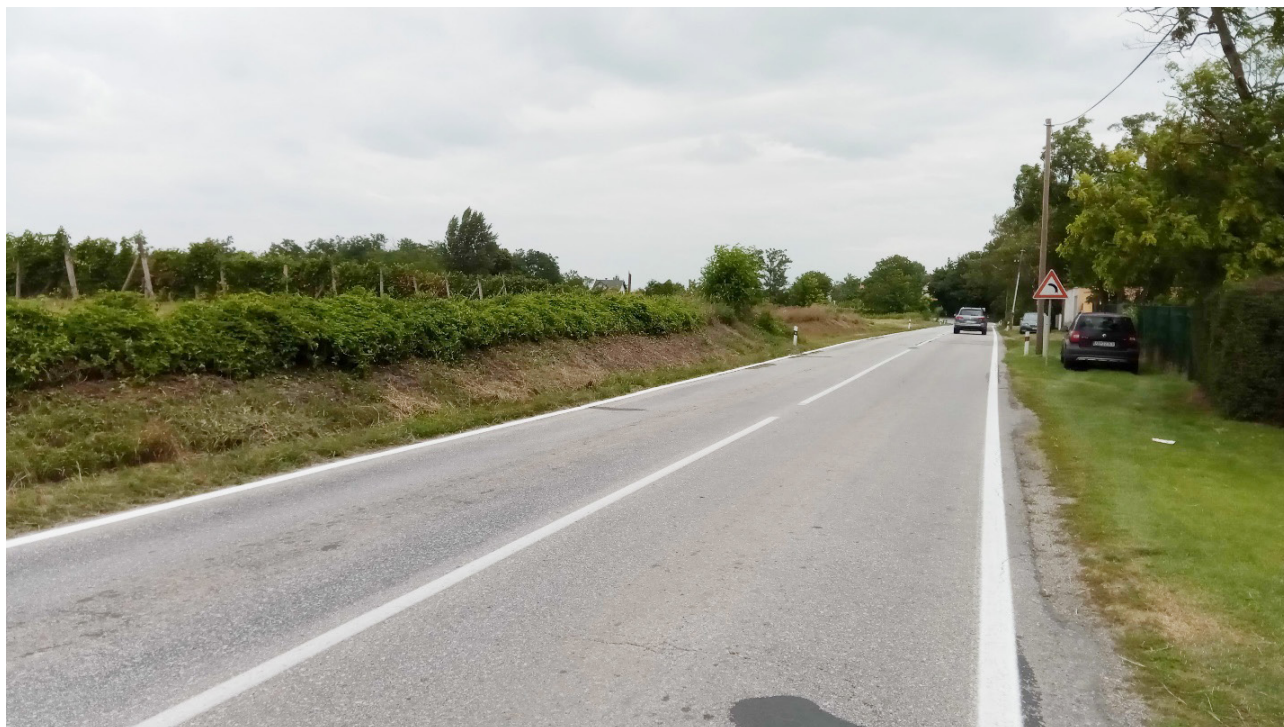
Section on national road 63 between Radvaň nad Dunajom-Žitava and Moča.

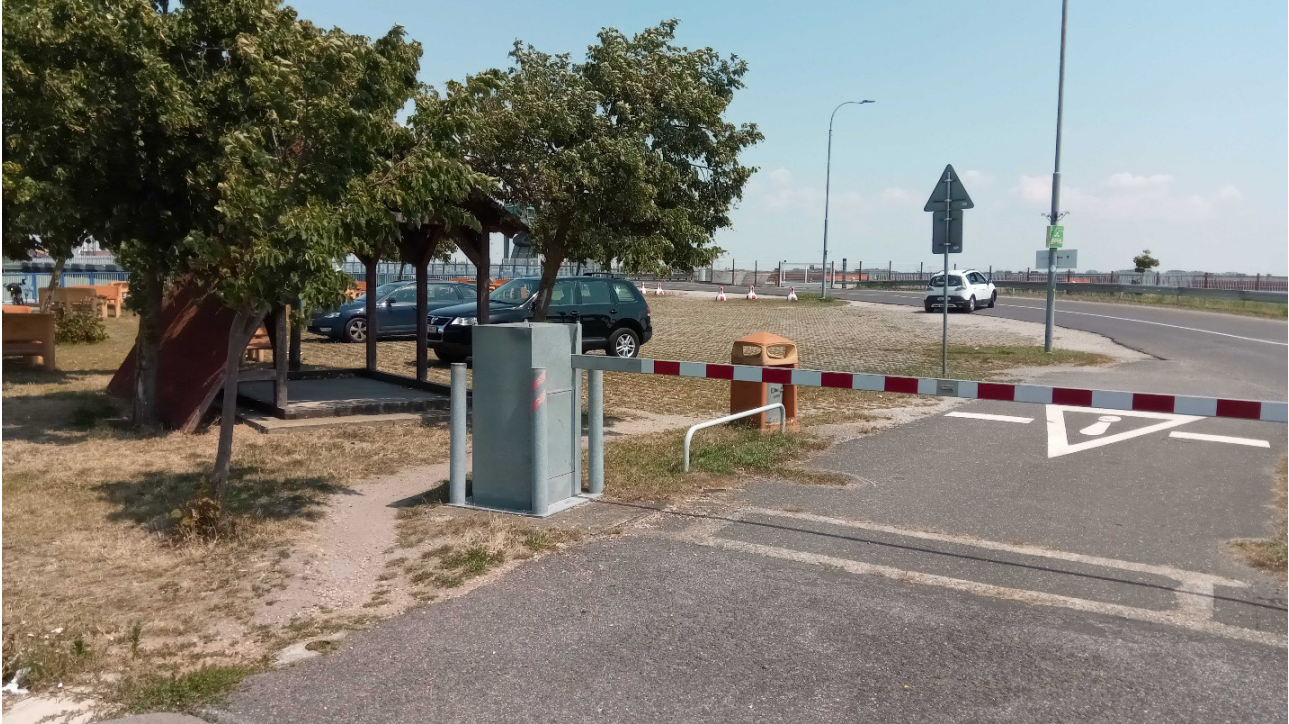
*One of the barriers that need to be adapted to meet the Additional European Certification Standard criteria.*

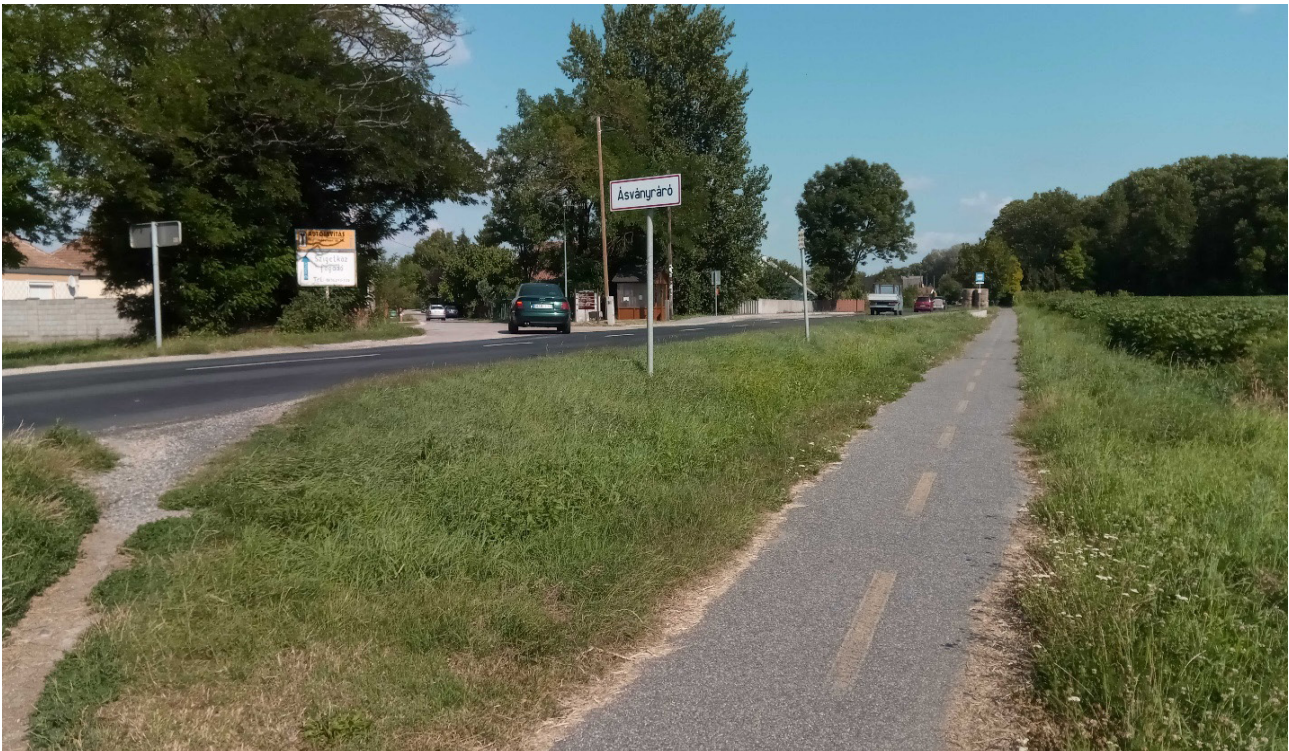
*High-quality cycle path, but the maintenance could be improved to prevent the edges from being overgrown.*

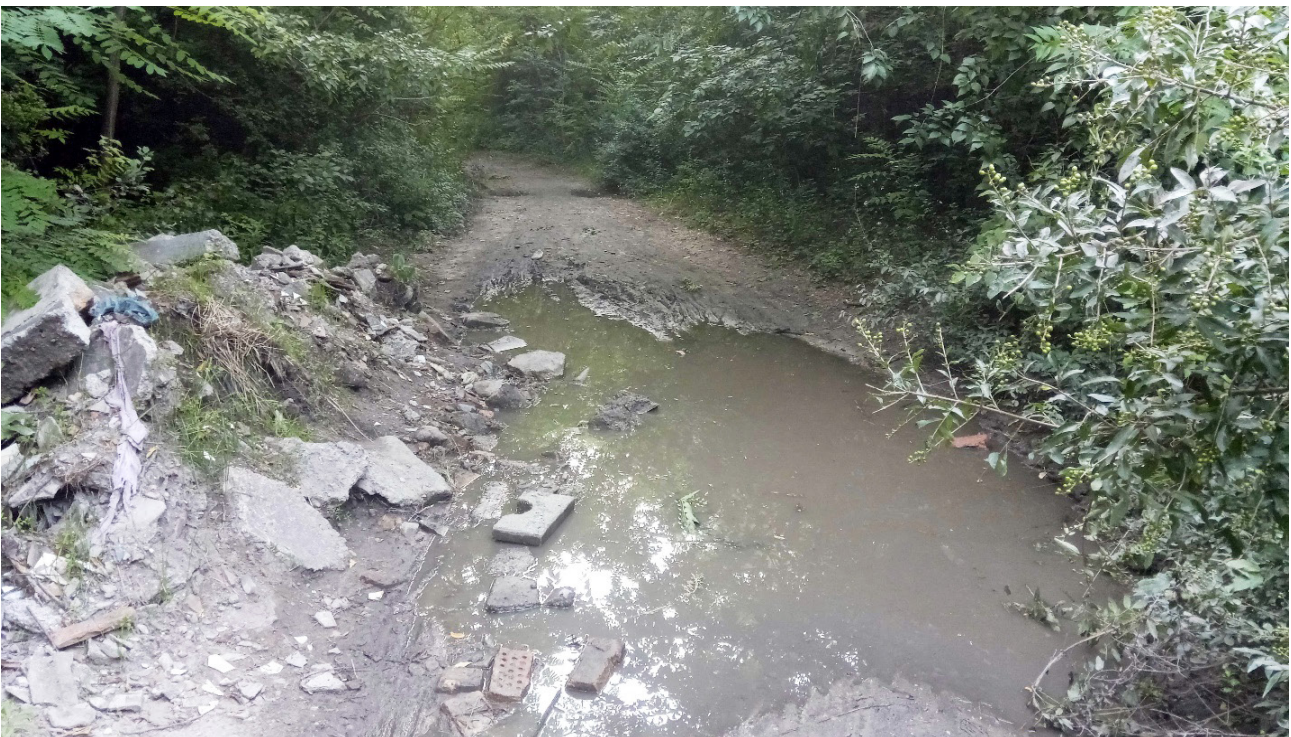
- Most of the badly rideable paths (16 km) in section 43: Ráckeve-Harta;
- Not rideable stretches have been identified in sections 34: Dunaszeg-Ács, 38: Ács-Esztergom, 41: Vác-Budapest and 42: Budapest-Ráckeve.

*Badly rideable surface in section 34.*

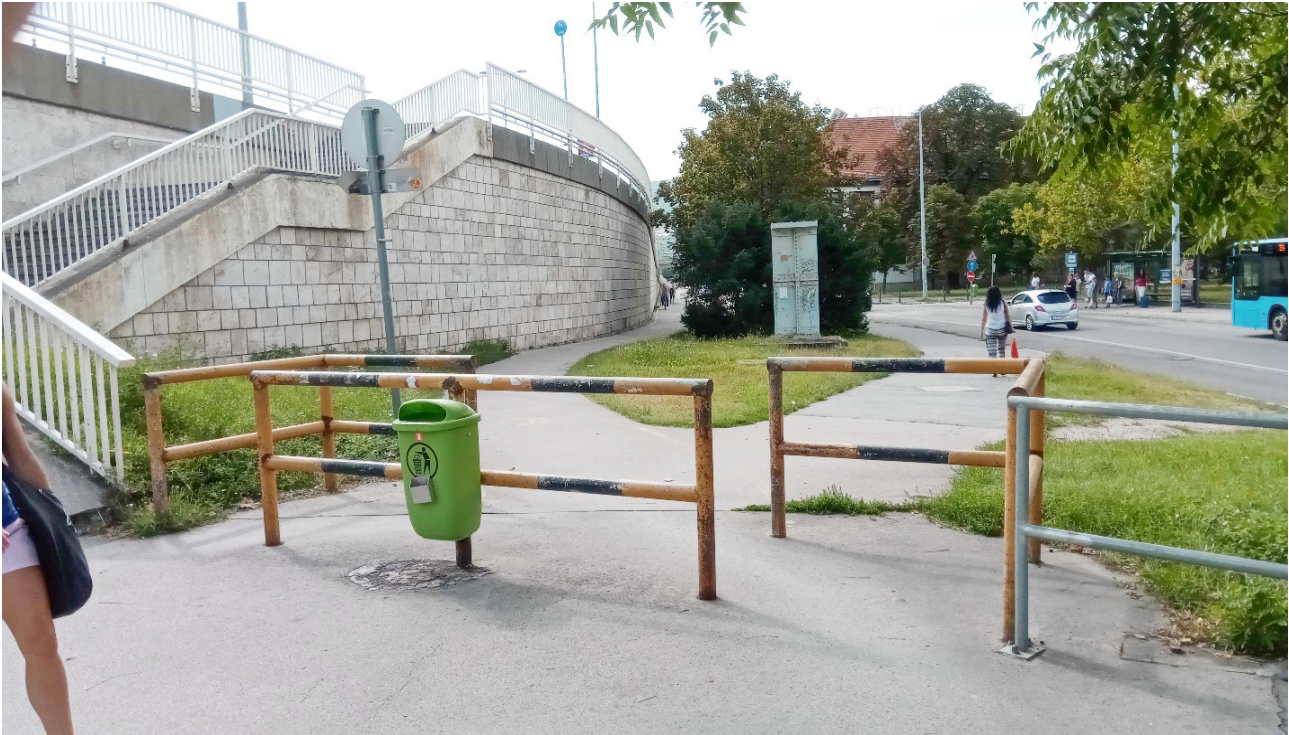
*Example of a chicane that is difficult to pass with a tandem or trailer.*

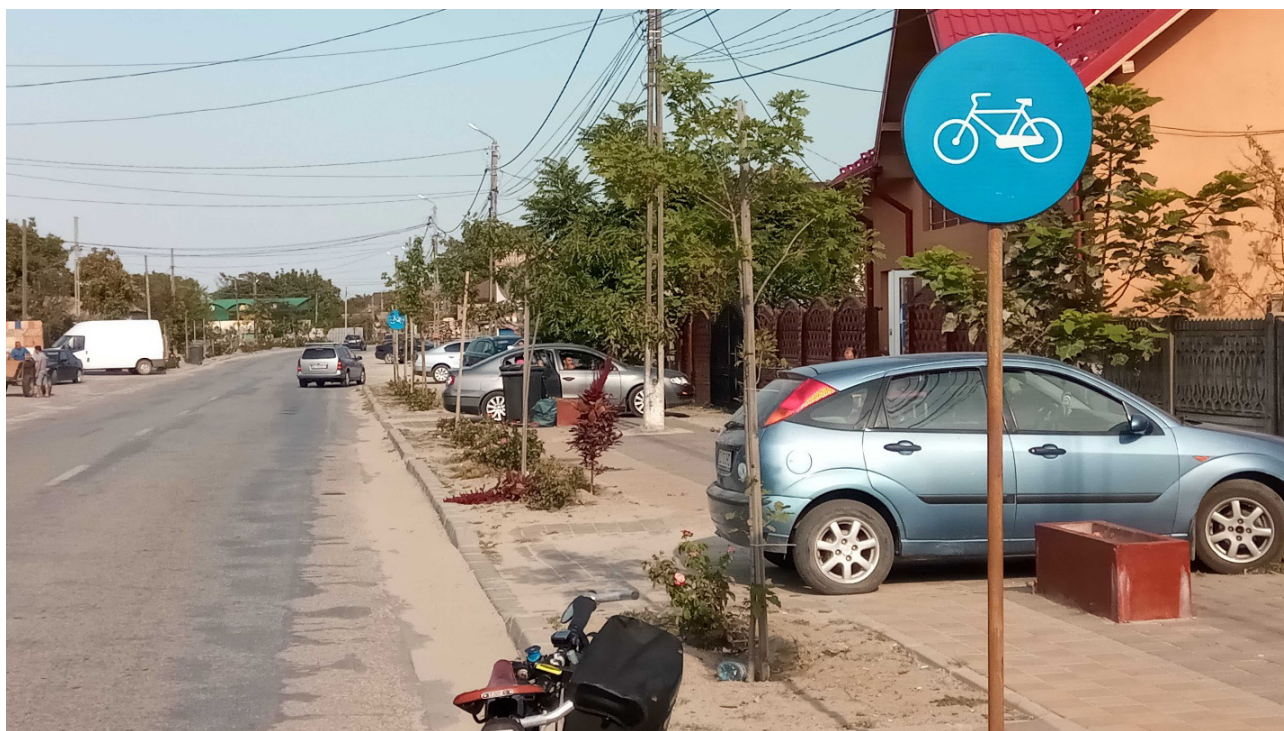
*Cycle path in Călărași (the one on daily section 72, not the Călărași on section 78) was completely unusable and therefore not taken into account during the evaluation.*

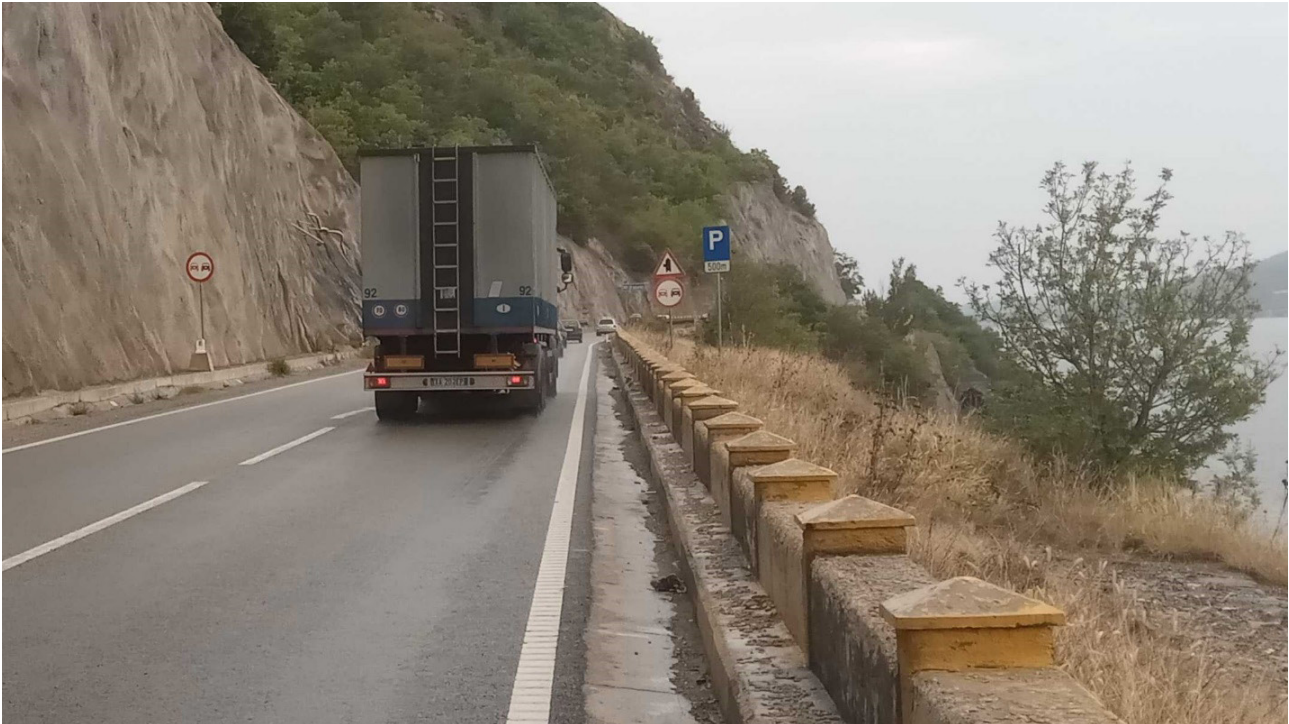
*Heavy traffic on the TEN-T road between Orsova - Drobeta-Turnu Severin (daily section 66).*

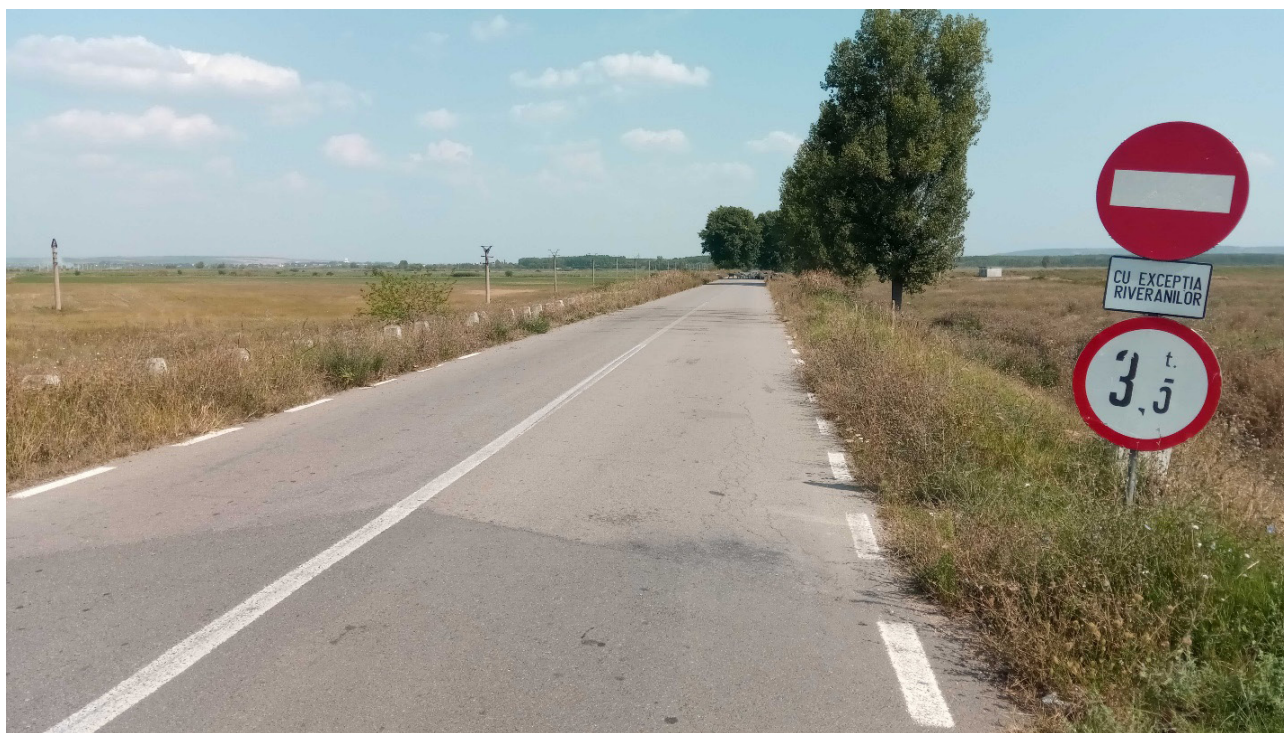
*Daily section 73 – entry forbidden, exception for residents, but not for cyclists.*
