EuroVelo 6 – Atlantic-Black Sea  
Transdanube.Pearls

# Route Assessment of EuroVelo 6 Atlantic-Black Sea

in Croatia, Serbia and Bulgaria  
Final Report

Written by Aleksander Buczyński,  
Ernst Fahrenkrug and Ed Lancaster (ECF)  
November 2018

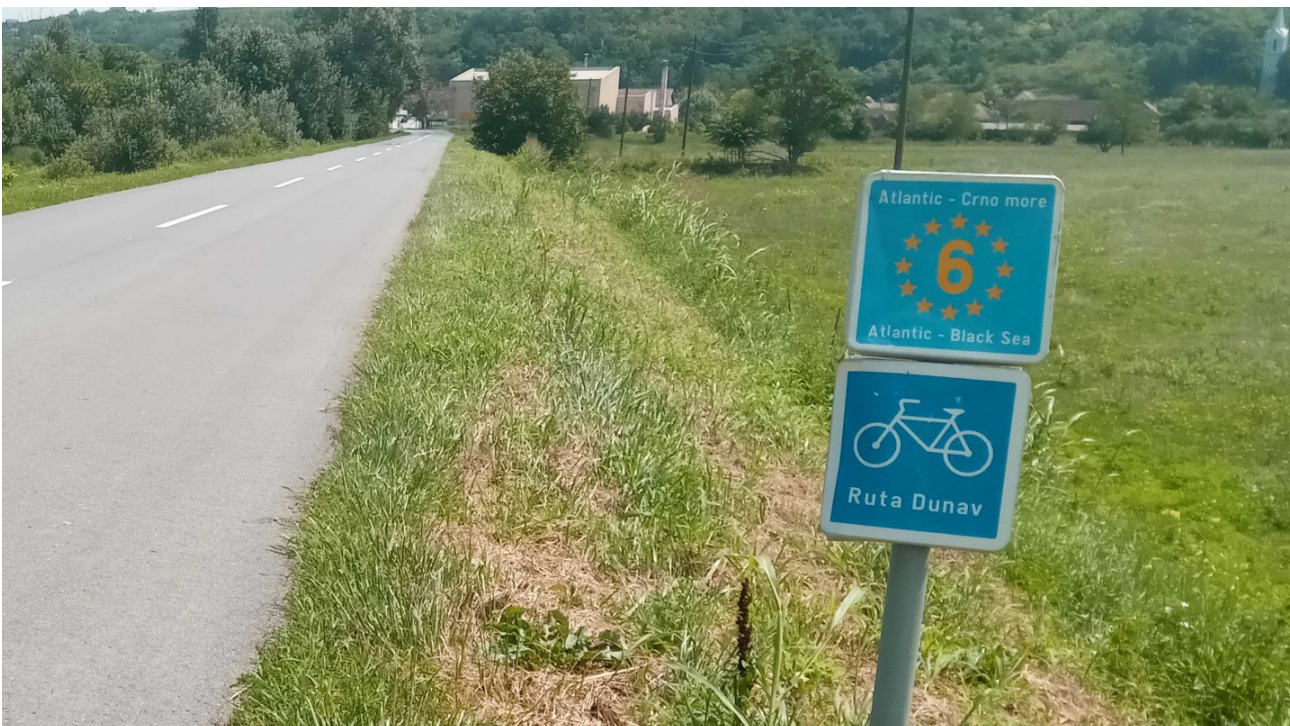
- 35 junctions with missing or confusing signs have been identified on the route. Additionally:
  - Existing EuroVelo signs are not in line with EuroVelo guidelines (already included in the UNECE Consolidated Resolution on Road Signs and Signals R.E.2. from 31st July 2009).

*EuroVelo signs not in-line with EuroVelo signing guidelines.*

3. Missing signs should be added.
  - a. While existing signs are clear enough, new signs should be designed according to the **EuroVelo signing manual**. Existing signs should be gradually replaced with the new design as part of maintenance of signposting.

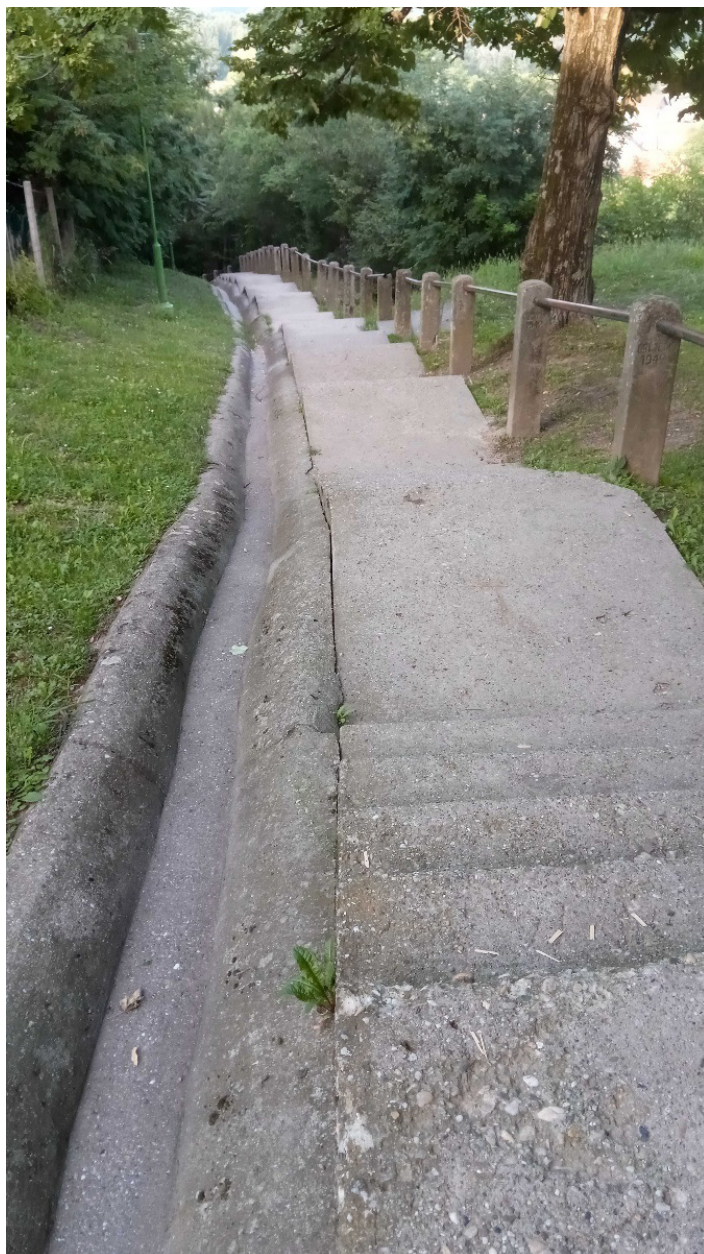
- In Ilok, the route leads over stairs; most of the steps are relatively gentle and equipped with a channel, but the first 10-15 steps are very steep and might form a significant barrier for heavily loaded or multi-track bicycles.

*Stairs in Ilok. To consider whether they should be a part of the EuroVelo route.*

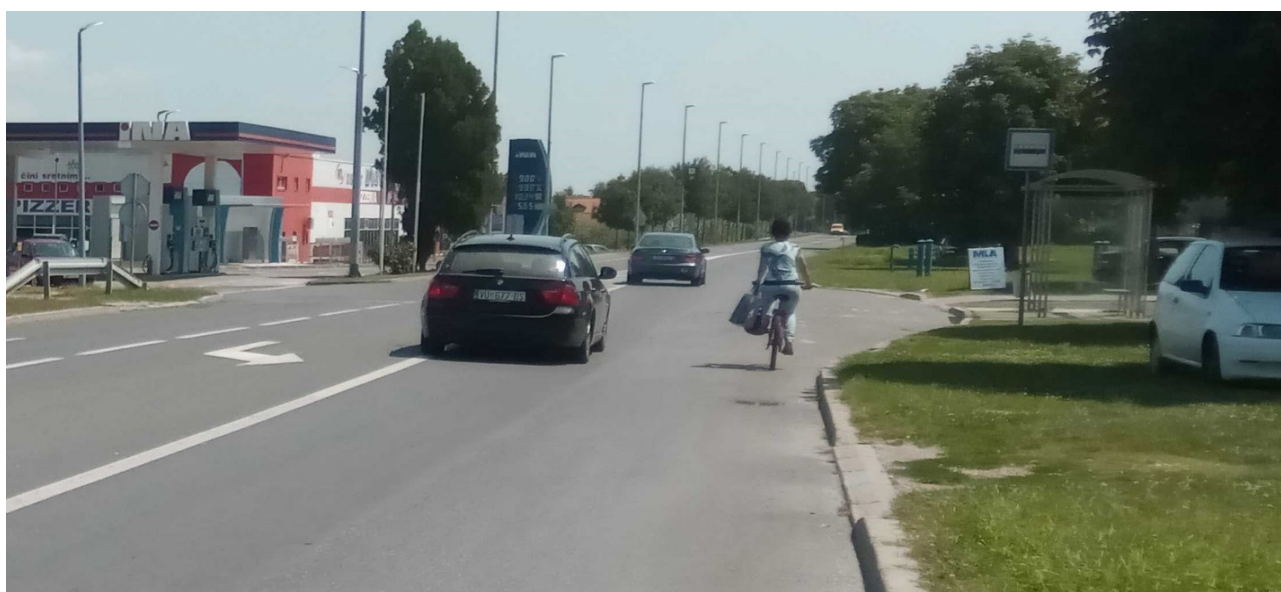
*National road D2 near Vukovar. Construction of a safe cycling path would benefit not only tourists but also local inhabitants.*

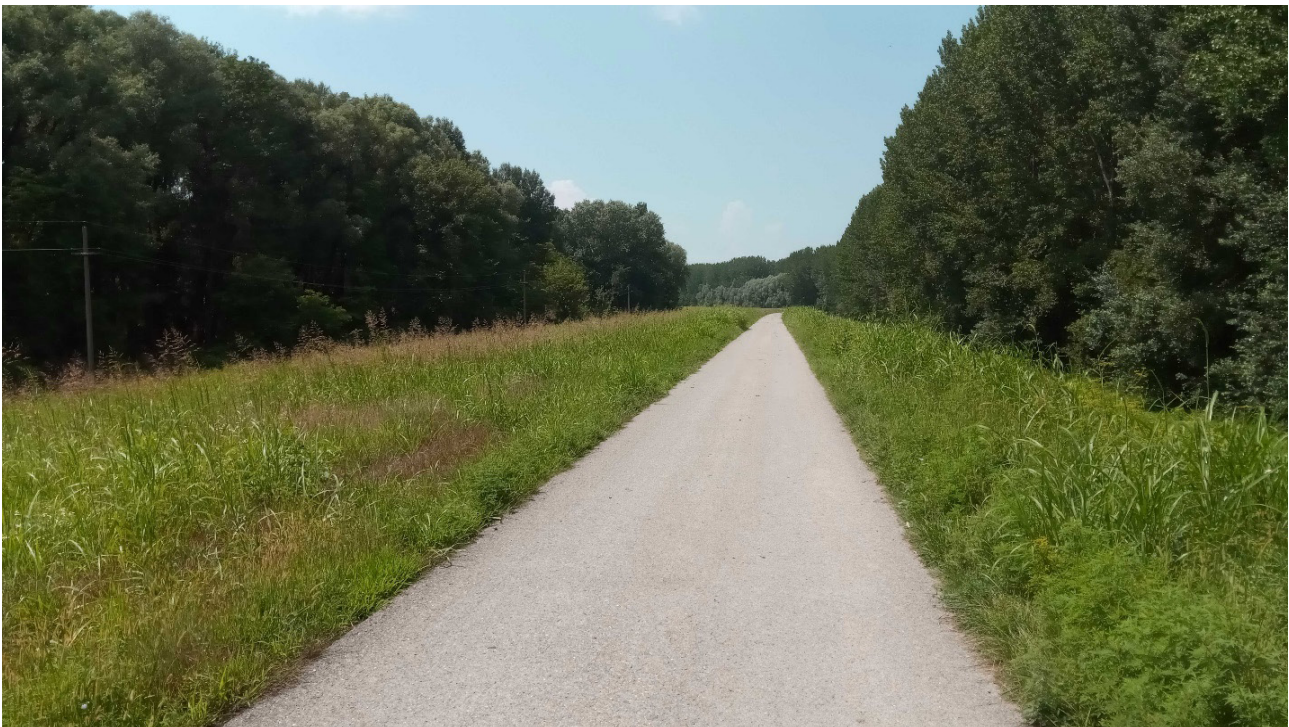
*A large part of EuroVelo 6 in Serbia already comprises quiet local roads with good surfacing. The challenge is to connect them to form a consistent route. Photo: section 54 near Kamariste.*

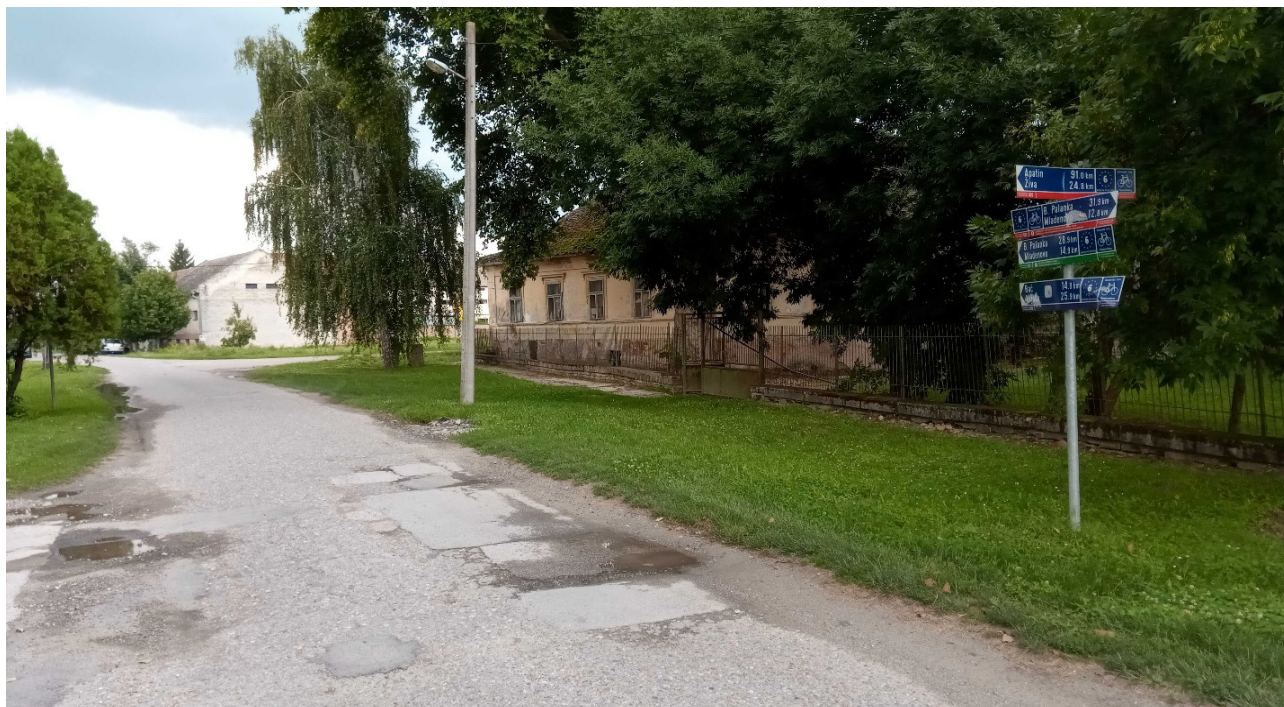
*Very good but slightly worn out signs.*

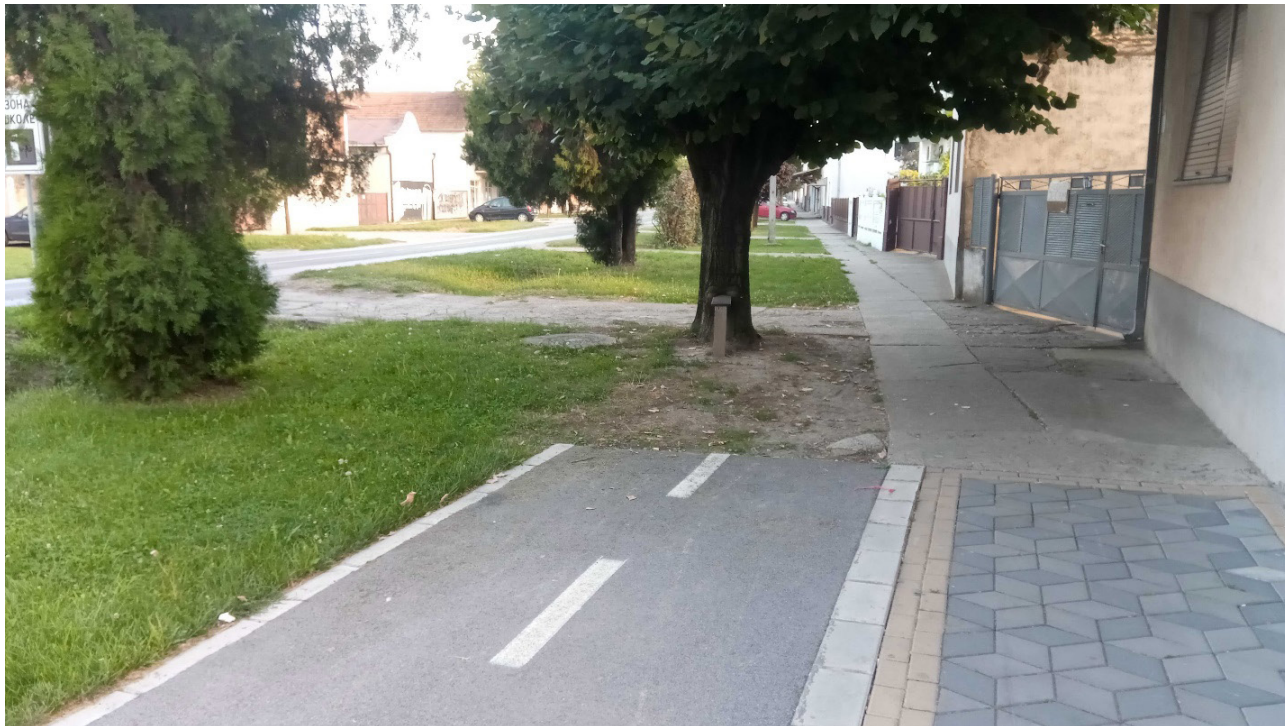
*Section 59: end of a cycle path in Zemun.*

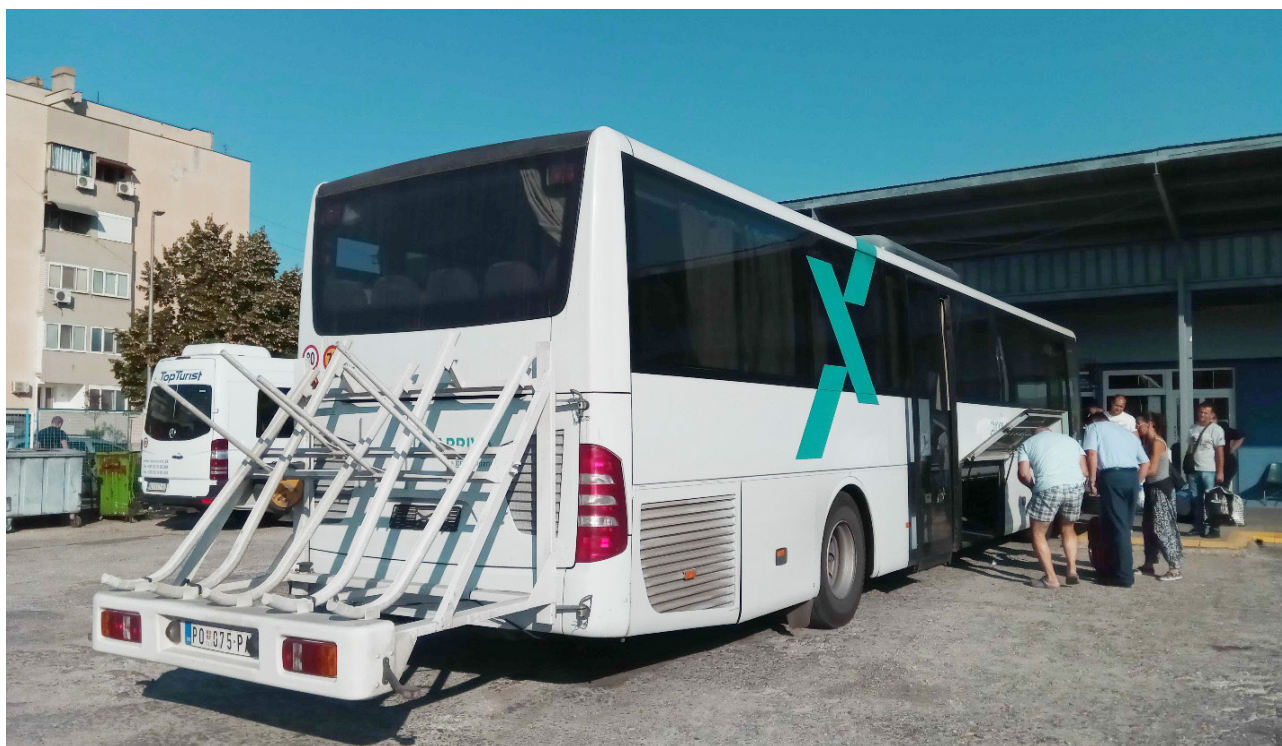
*New bus service between Belgrade and Kladovo, with bike rack.*

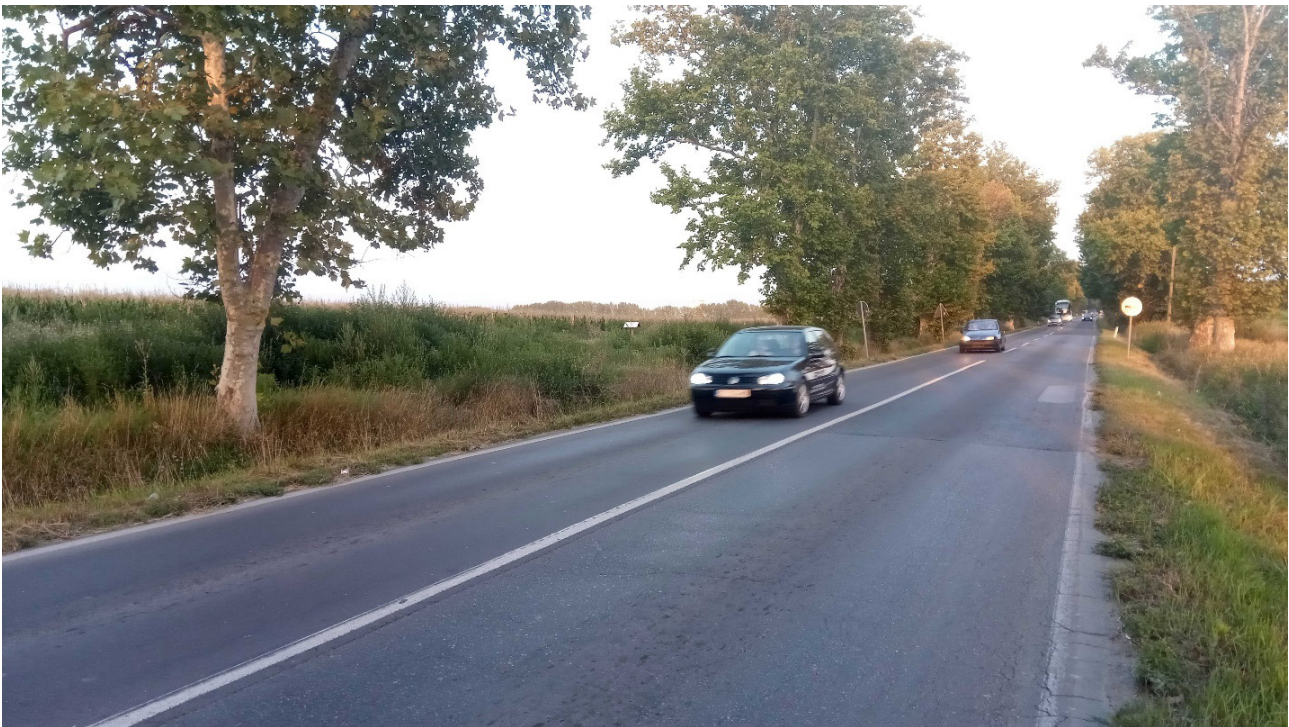
*Public road with high traffic and no cycle facilities between Zemun and Belgrade.*

- b. Many of the stretches where cycle paths are missing are located within a range of 10-20 km from large cities (Novi Sad, Belgrade). This means that significant synergies with commuting cycling can be realised, and there is a possibility to not only develop tourism but also address congestion, especially when considering the growing popularity of e-bikes.

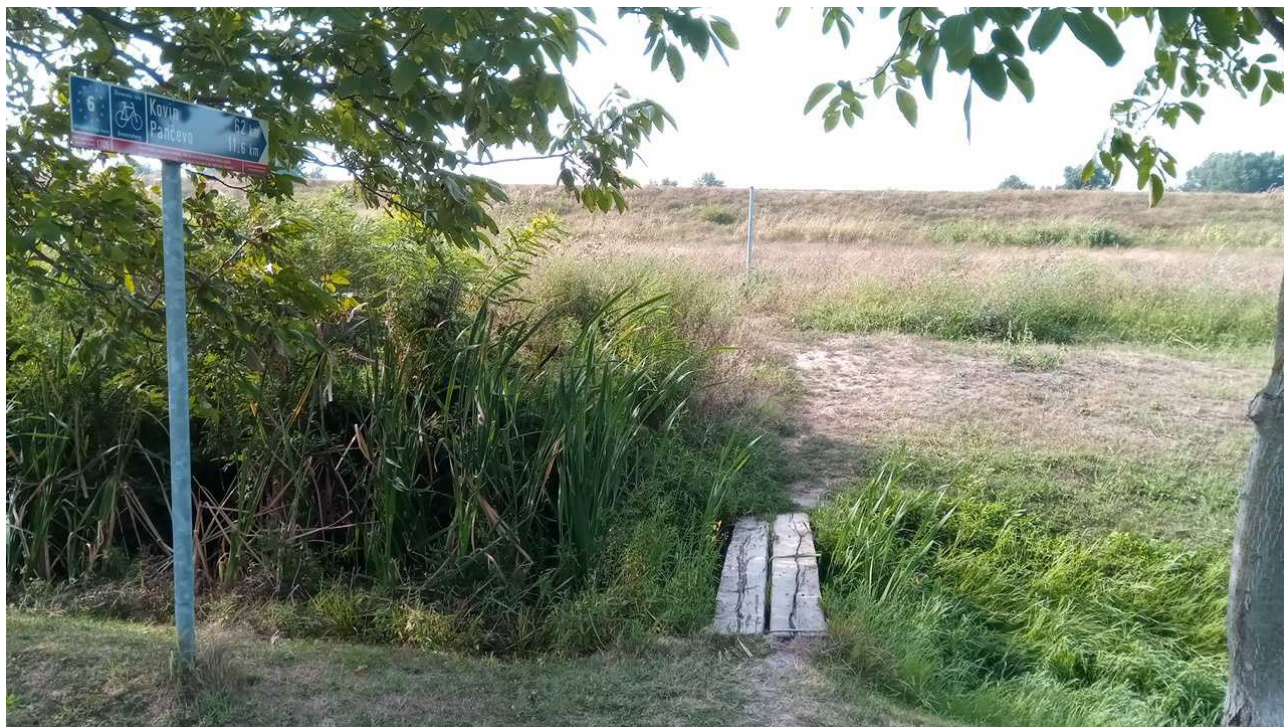
- 40 km (6%) of the route have been classified as comprising badly or not rideable surface:
  - Most of the not rideable kilometres are located in section 60: Belgrade-Kovin (11 km not rideable at all, another 4 km badly rideable).
  - Shorter stretches of 1-7 km are spread over eight different daily sections.
- No significant cultural or natural attractions were identified in daily sections 52-55, 61, 63, 90. This needs to be verified by the project partners.
- 16 junctions with missing or confusing signs have been identified on the route.
- Bike repair workshops, shops with spare parts or self-service stations could not be identified on two daily sections (54: Karavukovo - Backo Novo Selo, and 88: Brnjica - Donji Milanovac), not counting the border sections.
- There is no official national website promoting EuroVelo 6 in Serbia.

*Badly rideable stretch between Belgrade and Kovin.*

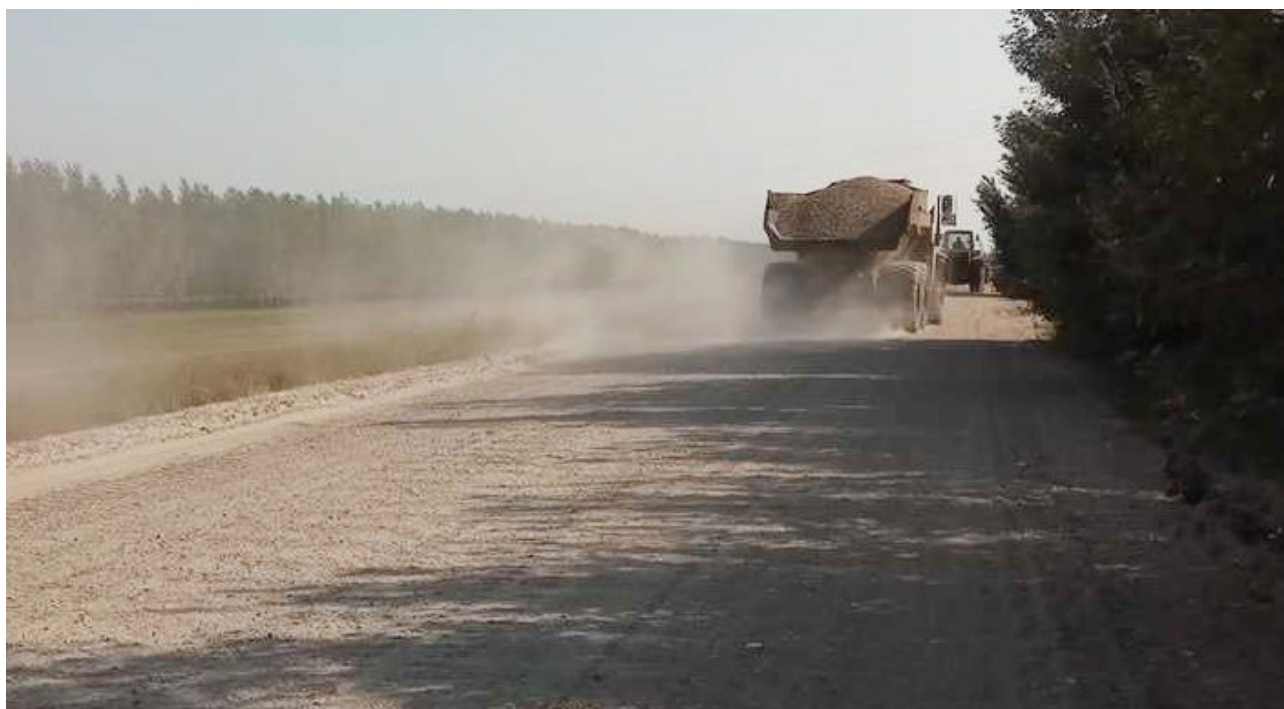
*Gravel surface on roads shared with motorised traffic can also create environmental challenges. Photo from section 61: Kovin - Stara Palanka / Bela Crvka*

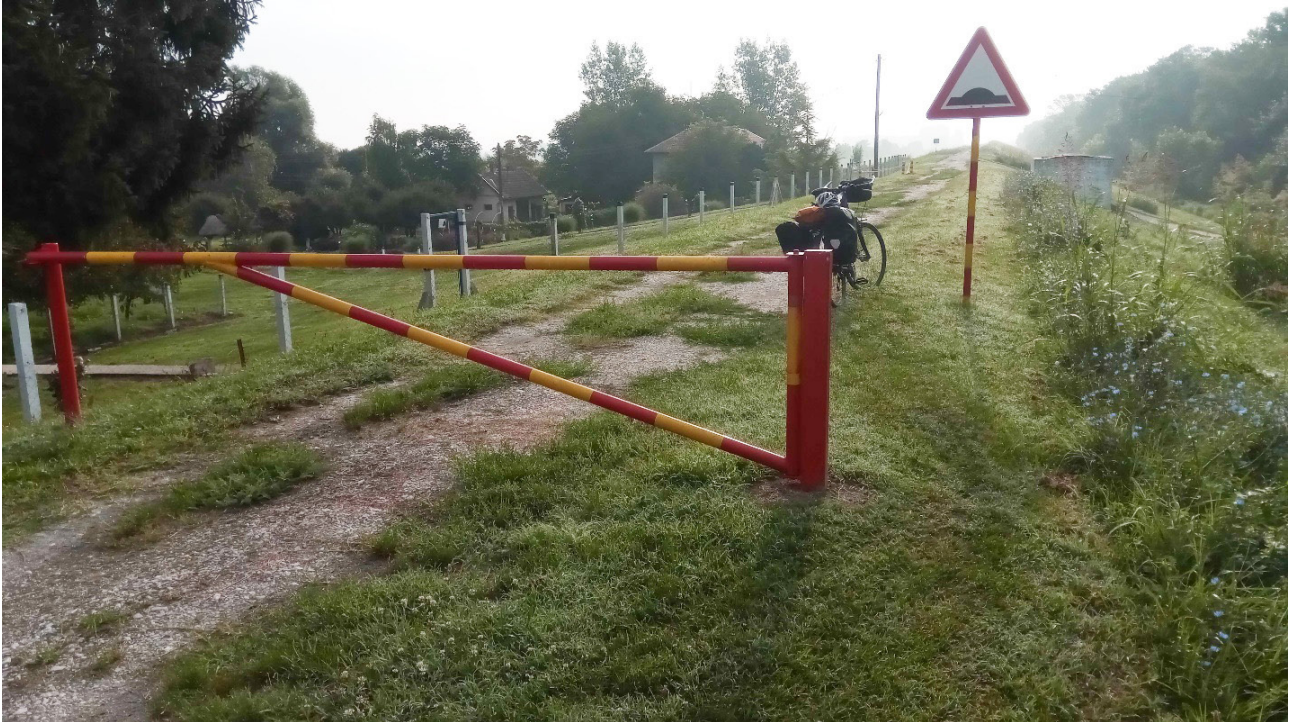
*Currently badly rideable, but potentially attractive part of daily section 53: Apatin-Karavukovo.*

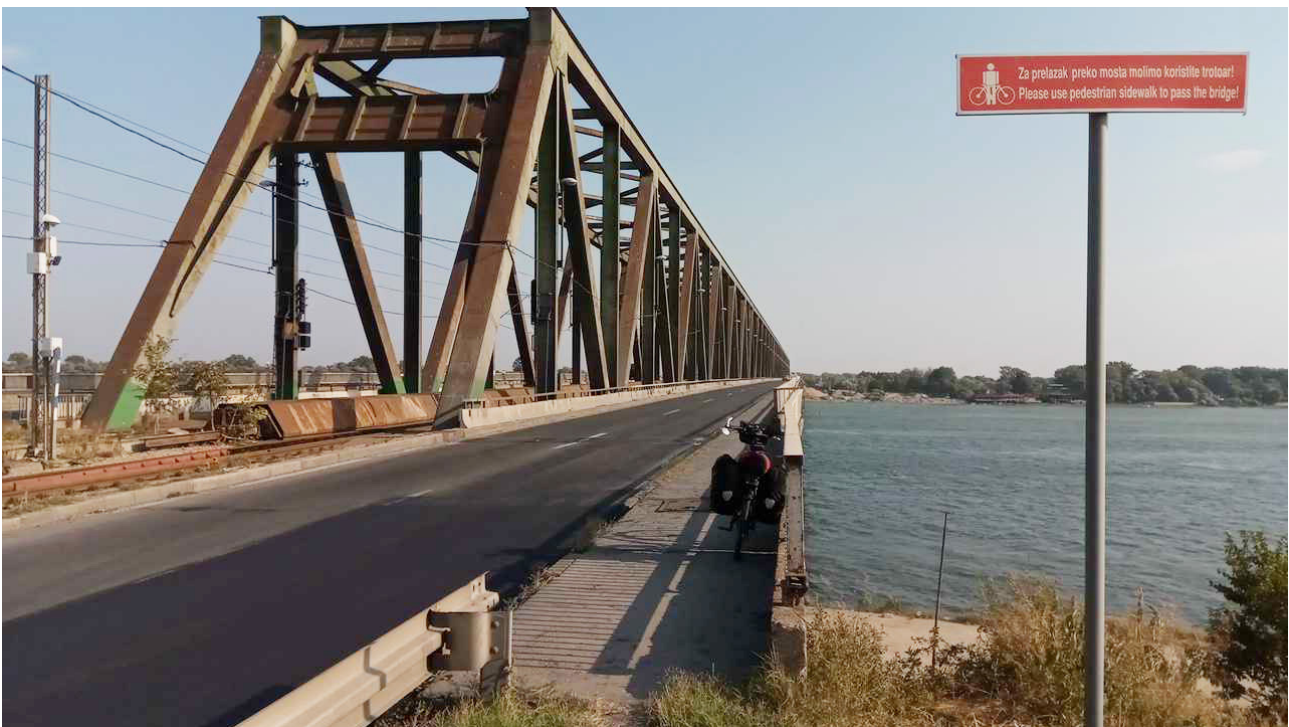
*Bridge in Belgrade, probably the biggest challenge to solve.*

2. Probably the biggest challenge would be the adaptation of “Pančevački most” in Belgrade to find space for a cycling path. But making the bridge more cycle friendly would also be important for commuter cyclists:

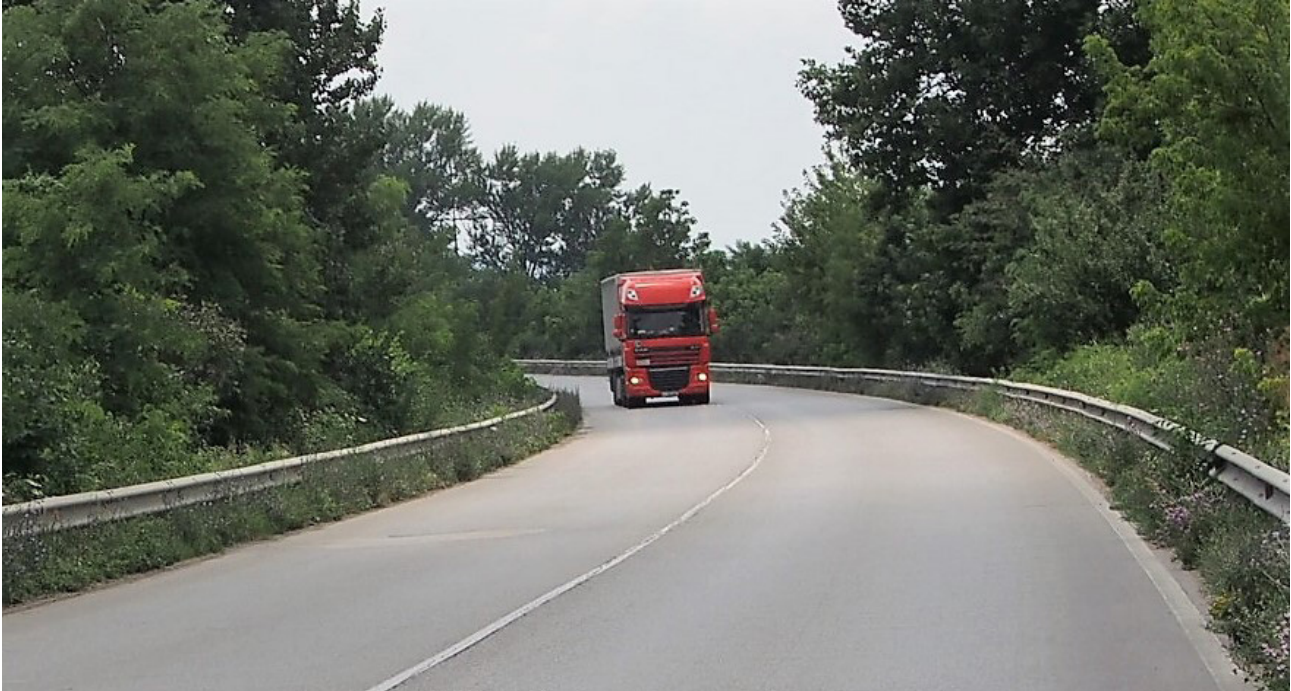
86 km (15%) of the Bulgarian route lead over roads with very high or high traffic, often with heavy trucks.

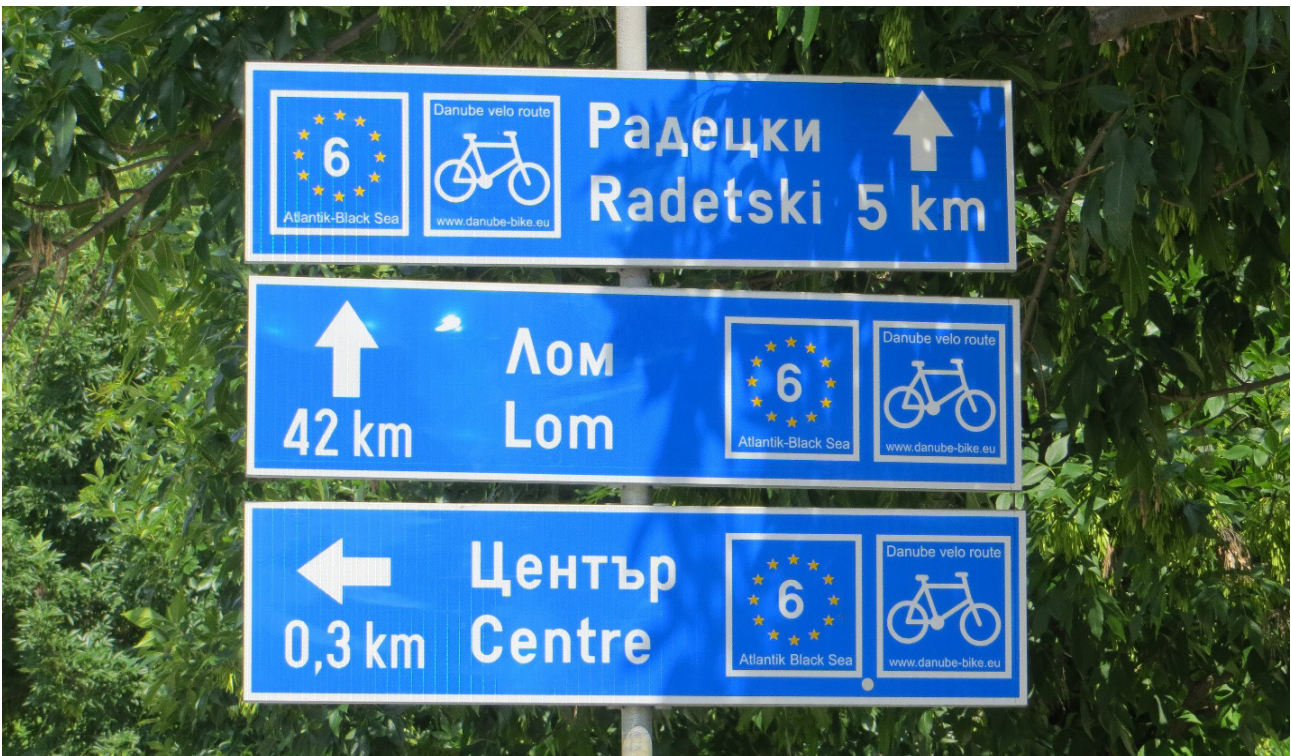
- Most of the required signs are missing – it is not clear whether the route is signed at all. The route inspector was told that (most of) the signs were removed by traffic authorities with an explanation that their blue colour confuses drivers who may think that they represent signage for motorised traffic. 86 km (15%) of the Bulgarian route lead over roads with very high or high traffic, often with heavy trucks.

To clarify with partners: are these signs legal in Bulgaria? One of the route inspectors reported that the road authority started to take them away as confusing for drivers because of the blue colour.
