# Route Assessment of EuroVelo 6 Atlantic-Black Sea

in Germany, Austria, Slovakia, Hungary and Romania  
Final Report

Written by Aleksander Buczyński,  
Ernst Fahrenkrug and Ed Lancaster (ECF)  
November 2018

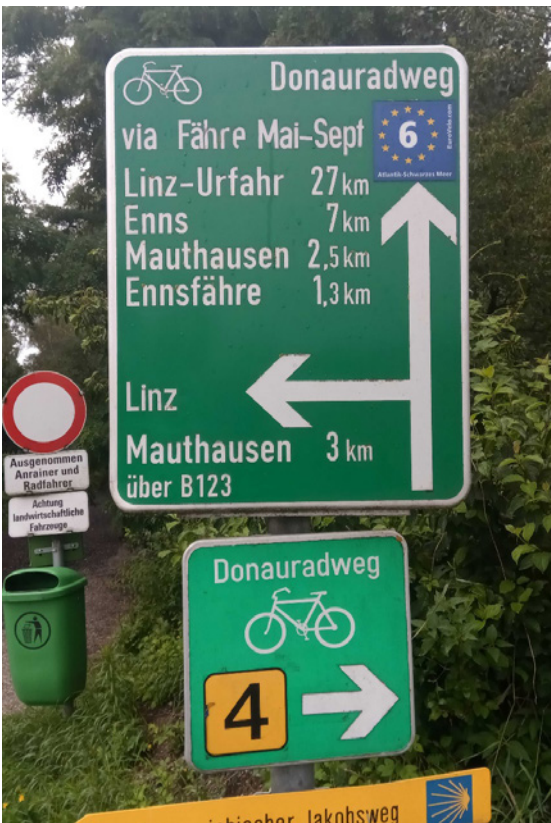
EuroVelo logo integrated in the upper, but not in the lower sign.

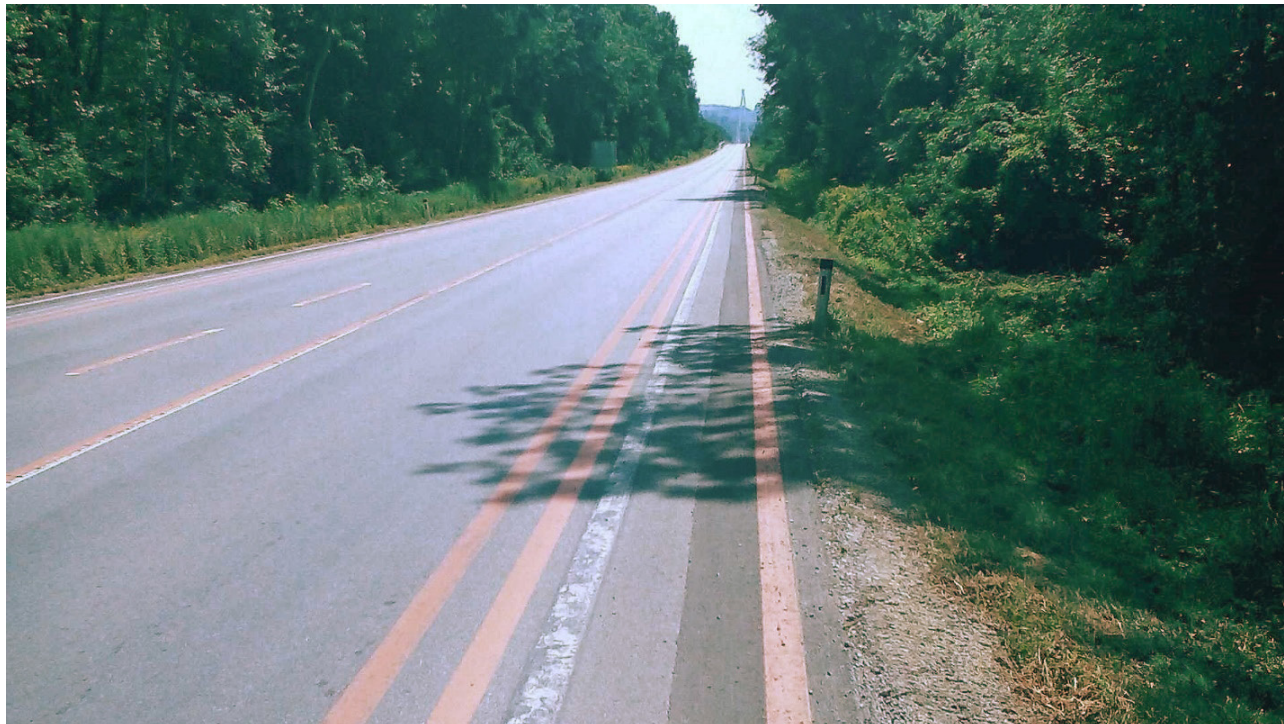
- One minor section in Vienna's city centre (daily section 19), shortly before the Stephansdom (public road, 4,000-10,000 units per day, 31-50 km/h).
- Narrow cycle lane on road no. 49 leading to the Andreas Maurer bridge.

*Narrow cycle lane on road nr 49 leading to the Andreas Maurer bridge (daily section 20).*

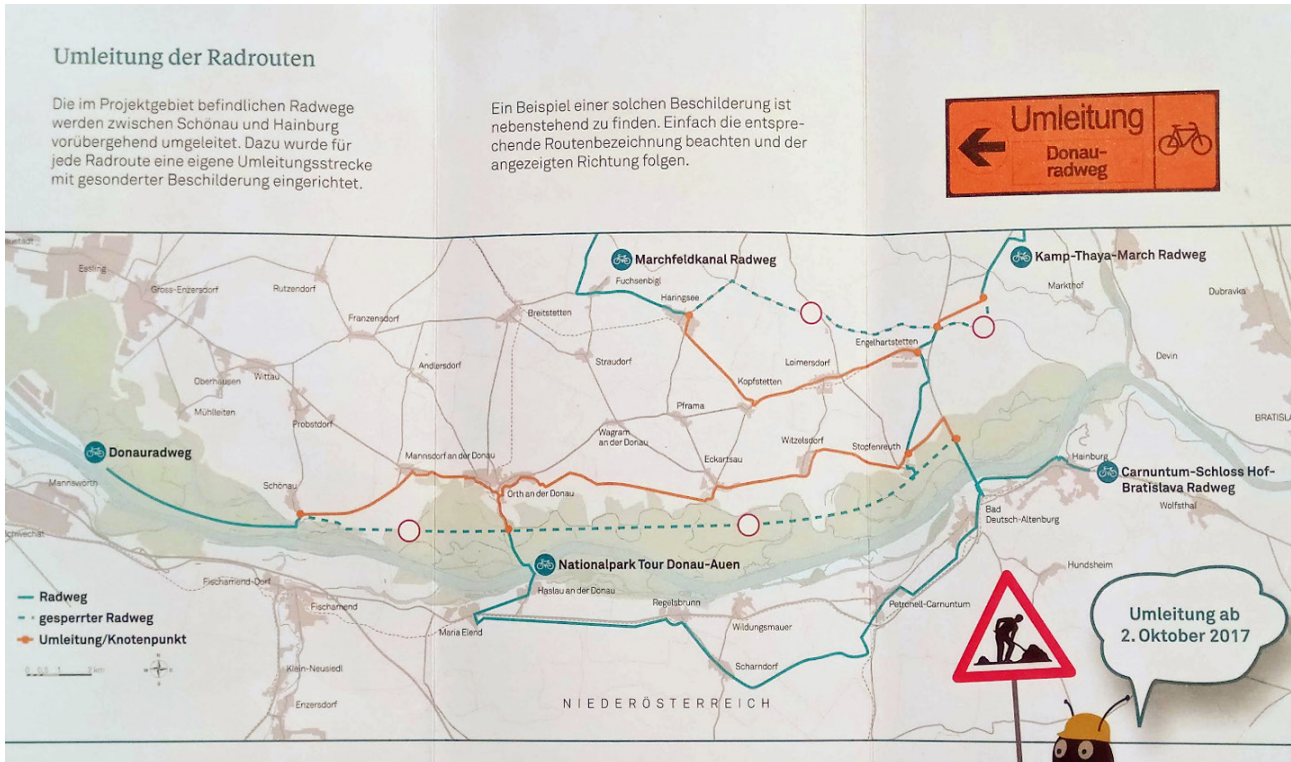
Significant parts of the main route were under reconstruction during the field survey.

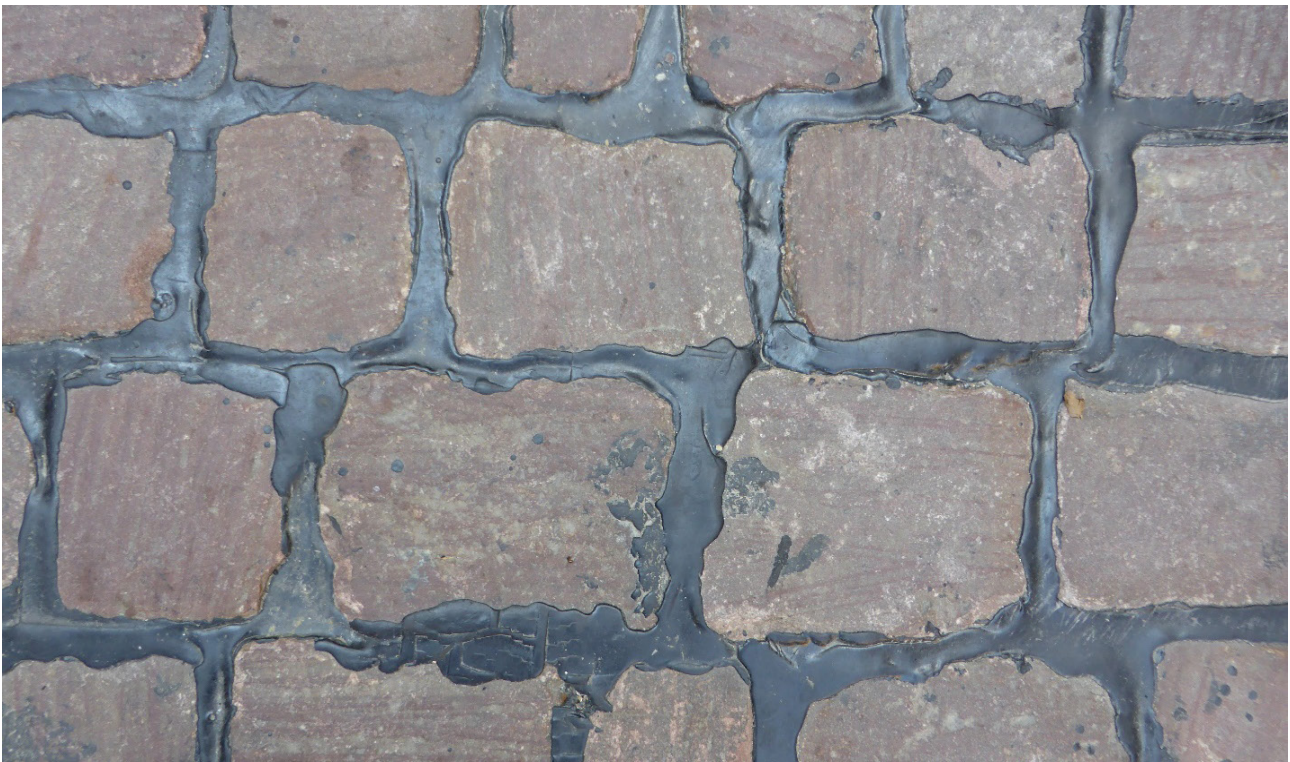
*Bike friendly cobblestone treatment in Freiburg im Breisgau – similar measures could be applied in Ybbs an der Donau.*

1. Around 10 km of cycling path along road number 3 between Grein and Hirschenau.
2. Adjusting the itinerary in the centre of Vienna to avoid the busy streets Marc-Aurel-Straße and Tuchlauben (section 19, km 63-64). The EuroVelo 6 route could simply follow the Danube bank and across the Prater part.
3. 3 minor sections of cycling paths between Engelhartzell and Wesenufer along roads with high traffic in daily section 22.
4. Improving surface on the access to ferry Enghagen am Tabor.
5. One minor section of cycling path or traffic calming in Mautern an der Donau (daily section 26)
6. Filling the gaps in between cobblestones in the centre of Ybbs an der Donau or finding an alternative route with better surface.

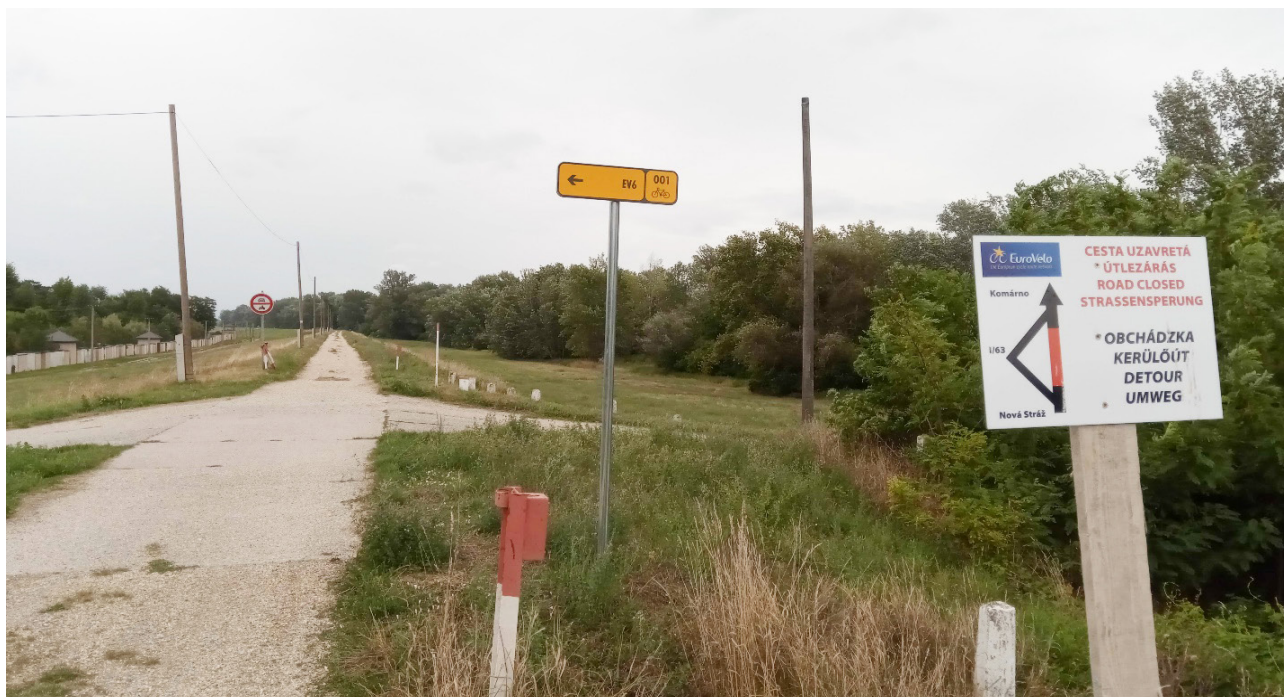
Detour to busy road between Nová Stráž and western border of Komárno.

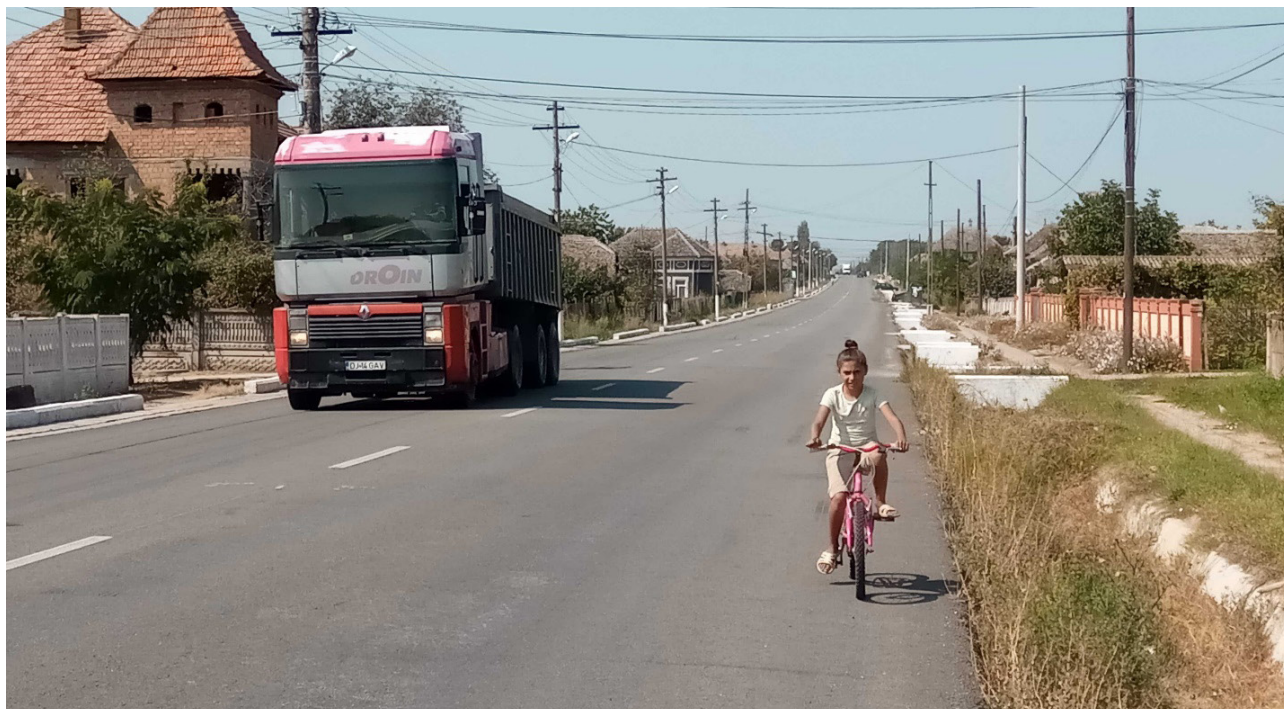
*In many locations, the construction of a cycle path would improve also safety of local inhabitants. Basarabi near Calafat, daily section 69.*

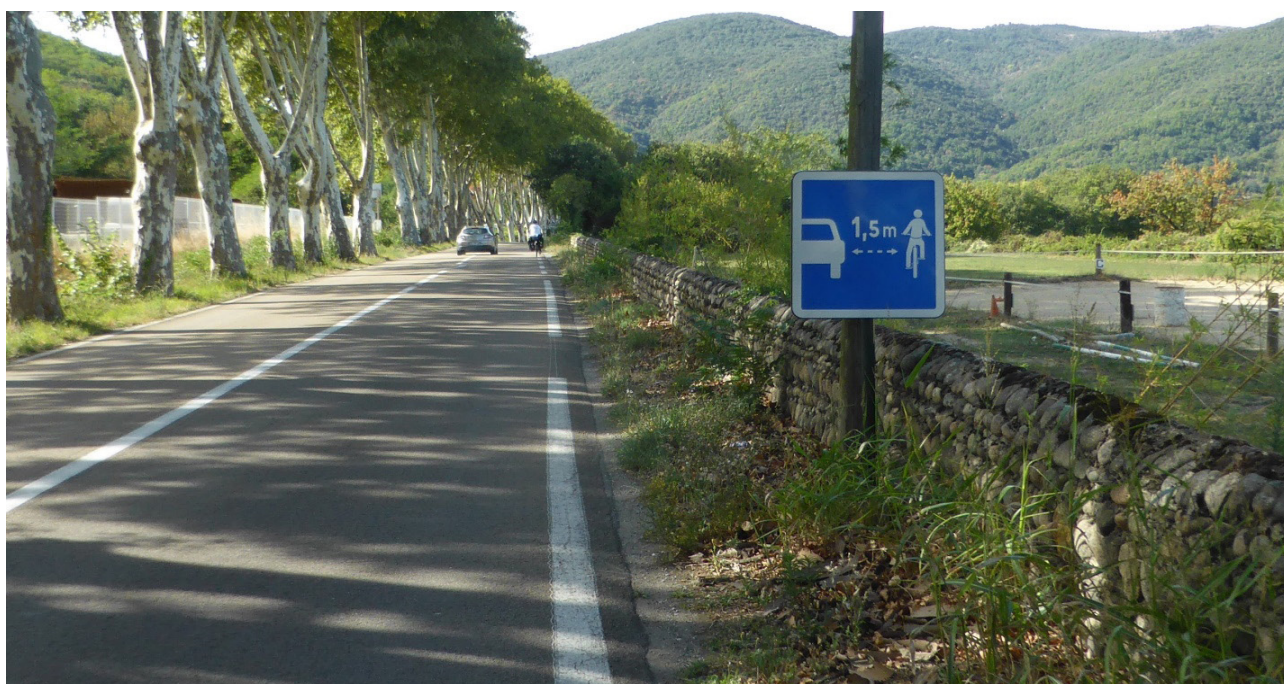
*Example (from France) of a sign for drivers indicating the minimum distance to cyclists that needs to be observed when overtaking.*
