# Route Assessment of EuroVelo 6 Atlantic-Black Sea

in Germany, Austria, Slovakia, Hungary and Romania  
Final Report

Written by Aleksander Buczyński,  
Ernst Fahrenkrug and Ed Lancaster (ECF)  
November 2018

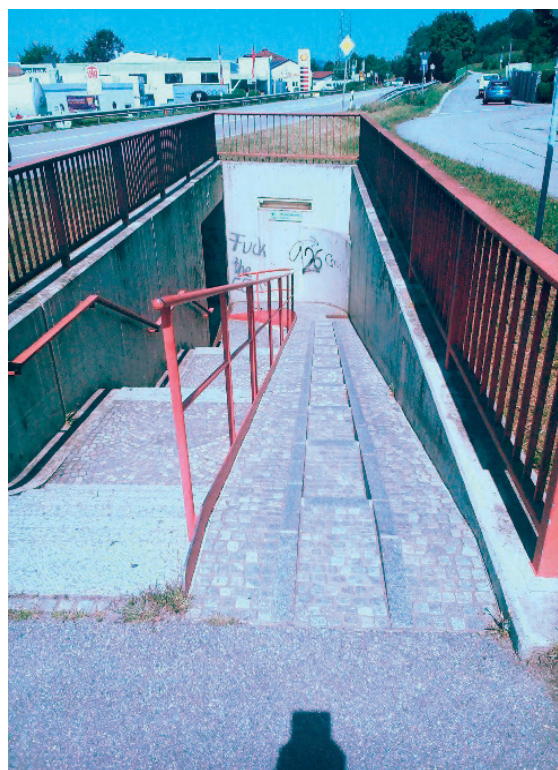
*Maierhof, west of Passau, DE*

- Stairs: The fittest cyclists, travelling with light luggage, can carry their bike up or down stairs, but for the majority of potential users, this is an important obstacle that might even be insurmountable. A total of three stairs were encountered during the route survey, including two in Germany and one in Croatia. However, these stairs were equipped with ramps, so they can be climbed with standard bikes.
- Chicanes and other bottlenecks with less than 1.3 m clearance: Such chicanes make it difficult to use the route with bicycles with trailers or with tandems, hand-bikes etc. They were encountered from time to time in most of the countries, slightly more often in Germany and Slovakia.
- Non-rideable surface (deep sand, mud, big rocks etc.) – this will be covered in the section on surface.

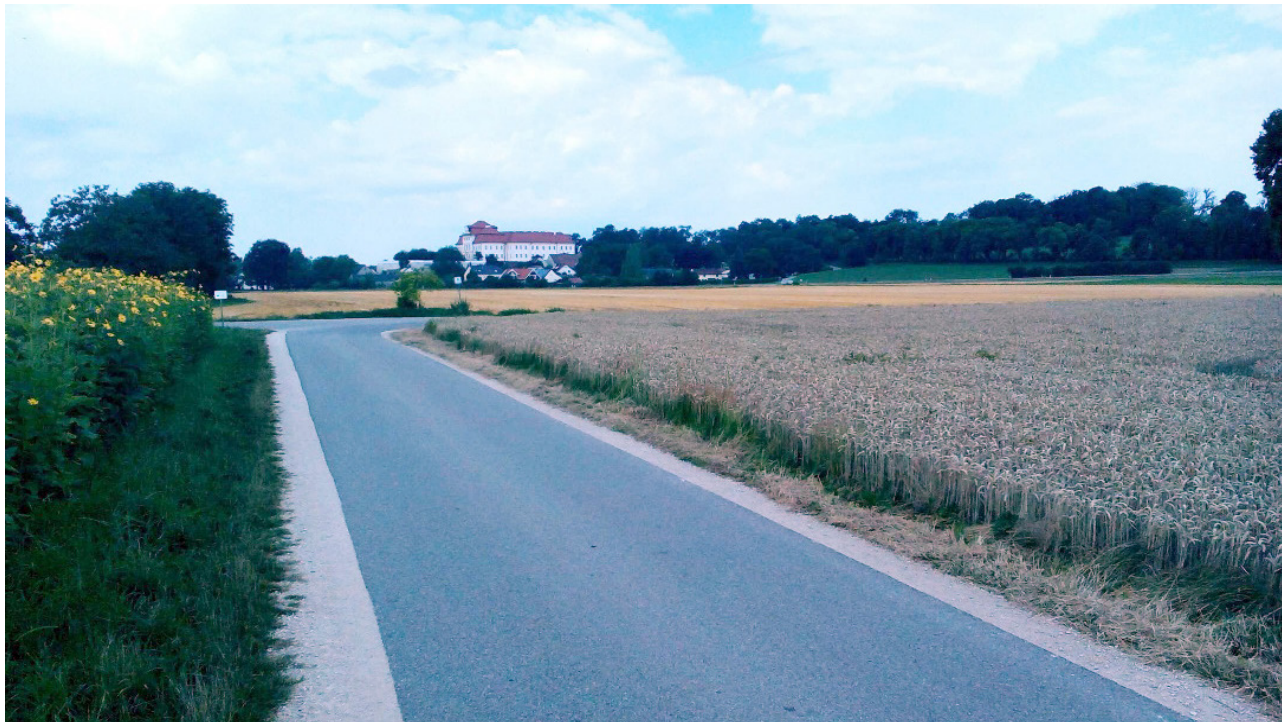
*Public road with low traffic behind Grünau castle (section 7).*

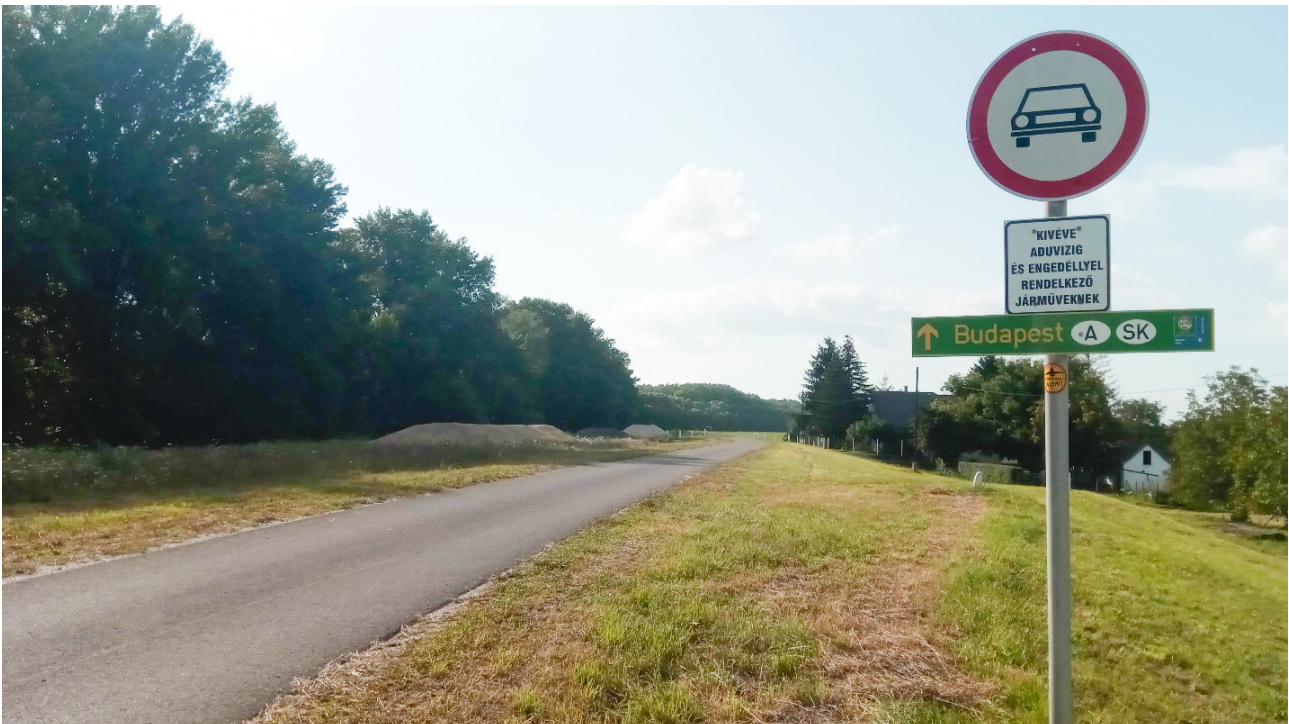
Section 45 near Mohacs – good example of long-distance route branding.

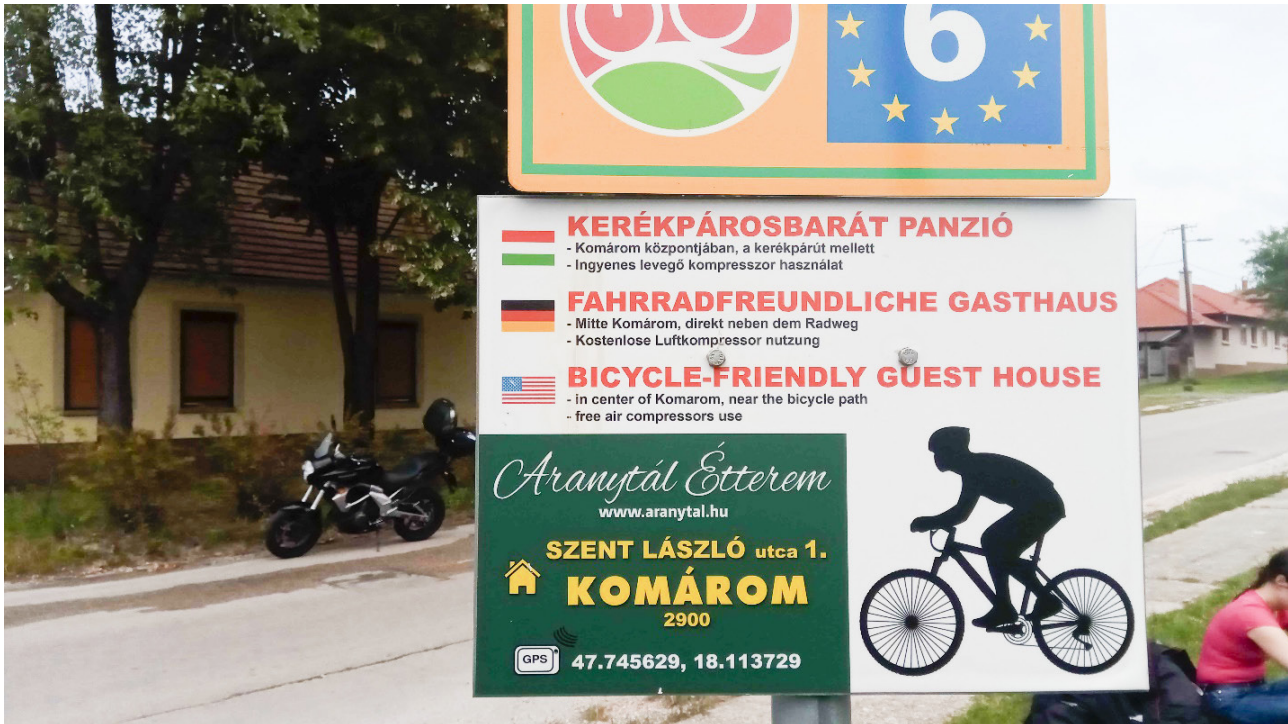
*Bicycle-friendly services in Komárom.*

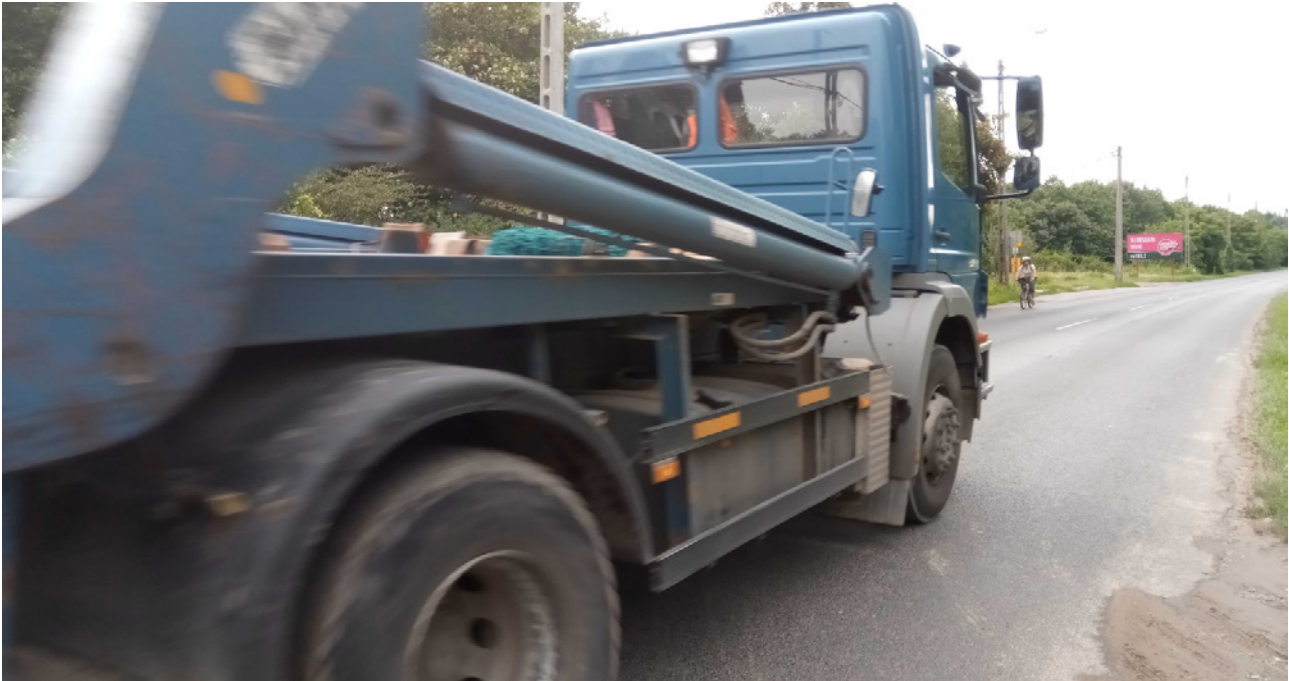
*Route on public road with heavy traffic in section 41.*

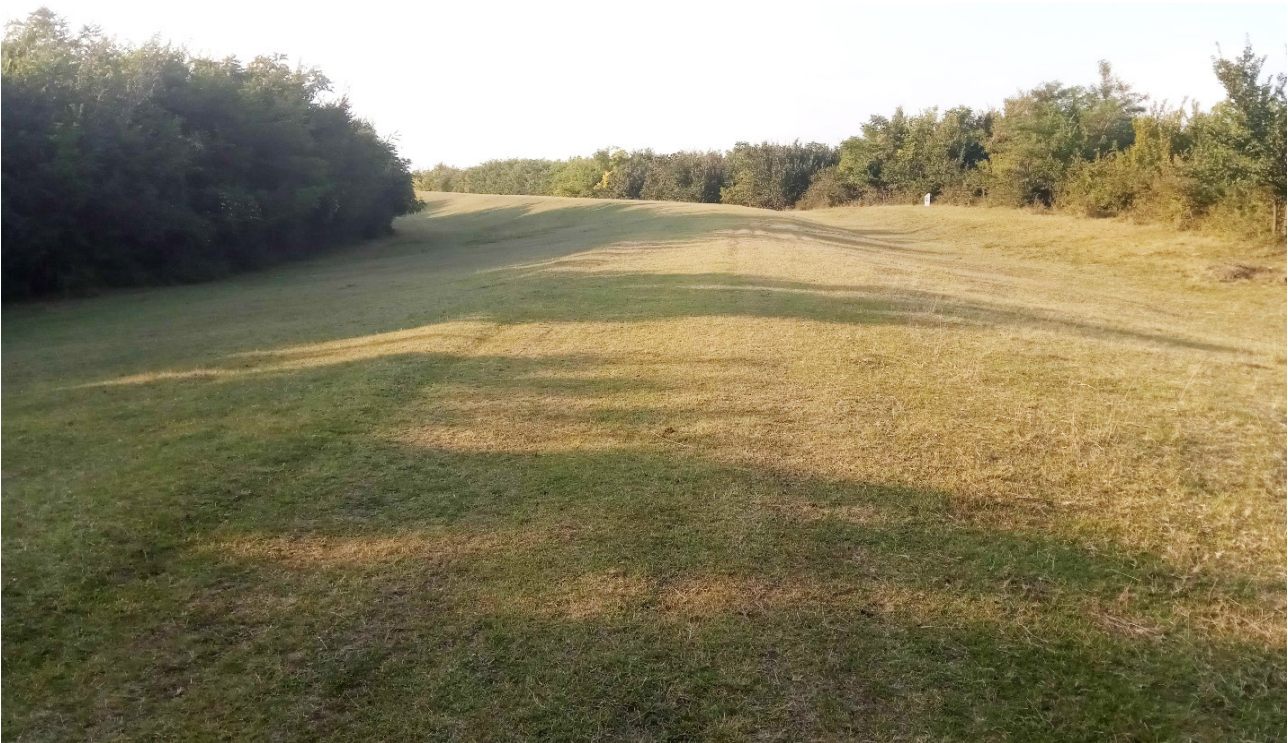
*A perfect location for a cycle path – section 43 north of Dunavecse.*

1. Approximately 90 km of cycle path need to be constructed. This is only a preliminary estimate, as in some locations...:
  - a) A cycle path does not necessarily have to be constructed directly along the main road but could be located closer to the river. This would create a route that is more attractive, provides more opportunities to enjoy nature and less exposure to noise from motorised traffic. This means that the total length of cycle path to be built can differ. It could be longer or shorter, depending on the section.

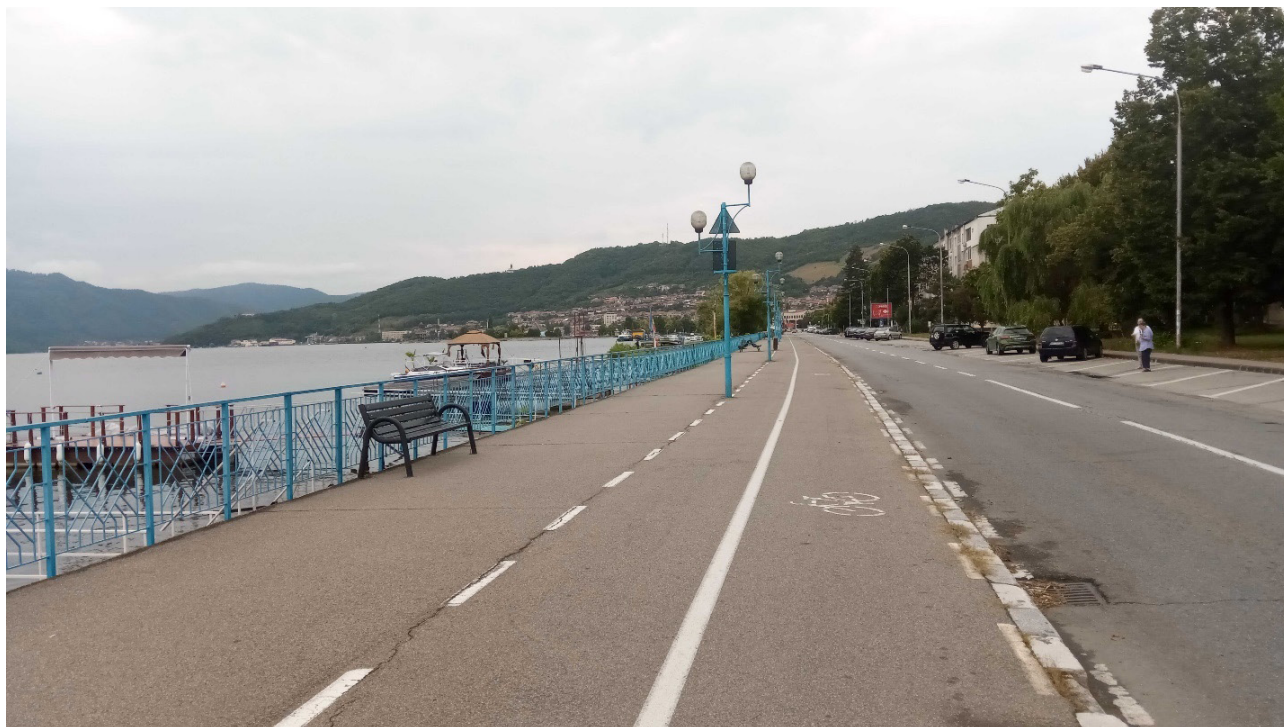
*Orsova – one of the few locations with a dedicated cycle path.*

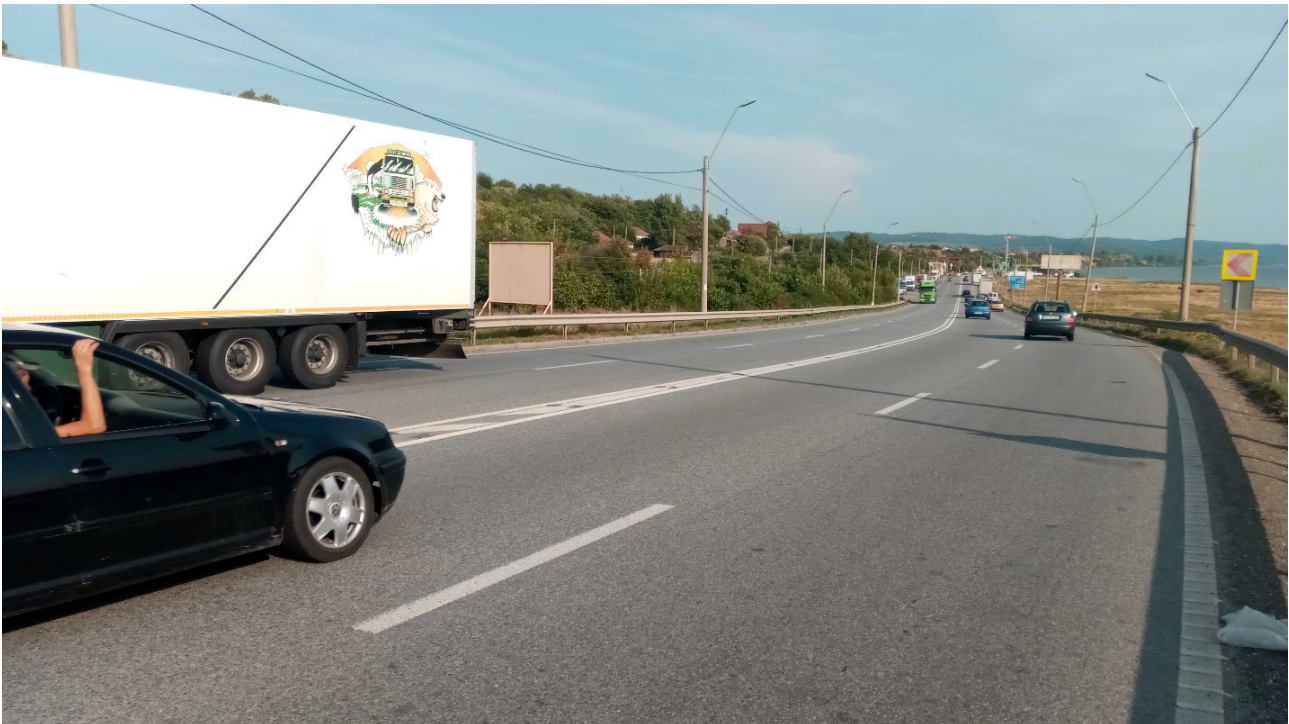
*Daily section 67, between Drobeta-Turnu Severin and Simian.*

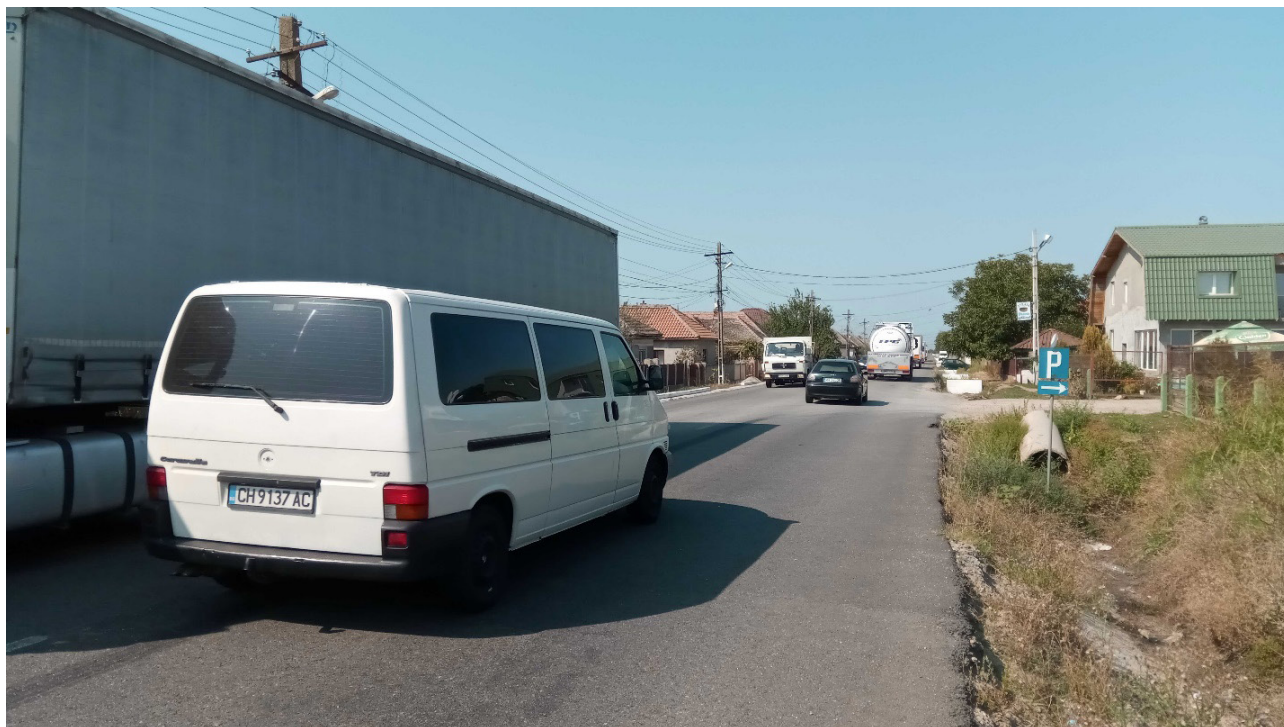
*Daily section 69: Garla Mare-Calafat.*

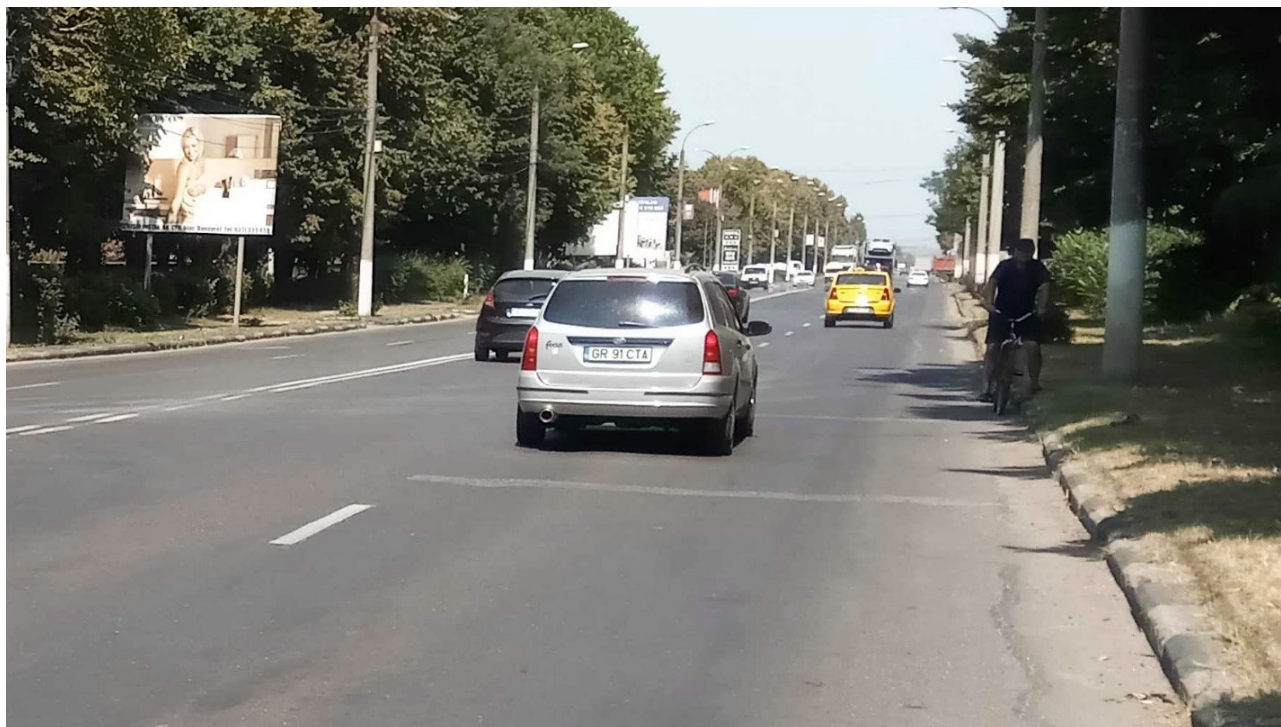
Daily section 75. Traffic on road number 5 leaving Giurgiu estimated to reach 25-30,000 vehicles/day.

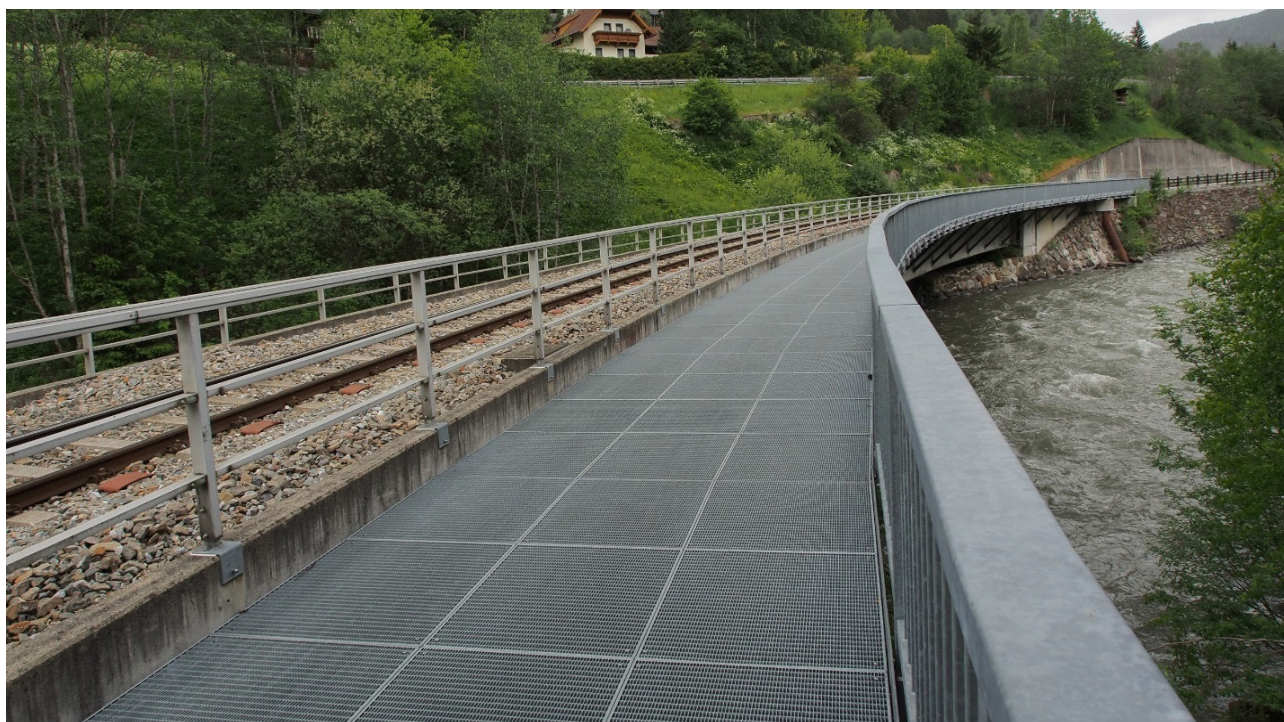
*Cycle path attached to railroad embankment – one of the possible solutions for daily section 66. Photo from Murradweg between Tamsweg and Madling (Austria).*
